Environmental and Rehabilitation Compliance Report Mining Lease ML1723

(Including Mining Purpose Leases 559,592,622,623,628 and 654)

Boral Berrima Cement Works 2019 Reporting Period

**Boral Cement Ltd.
Berrima Cement Works,
Taylor Avenue,
New Berrima,
NSW 2577**

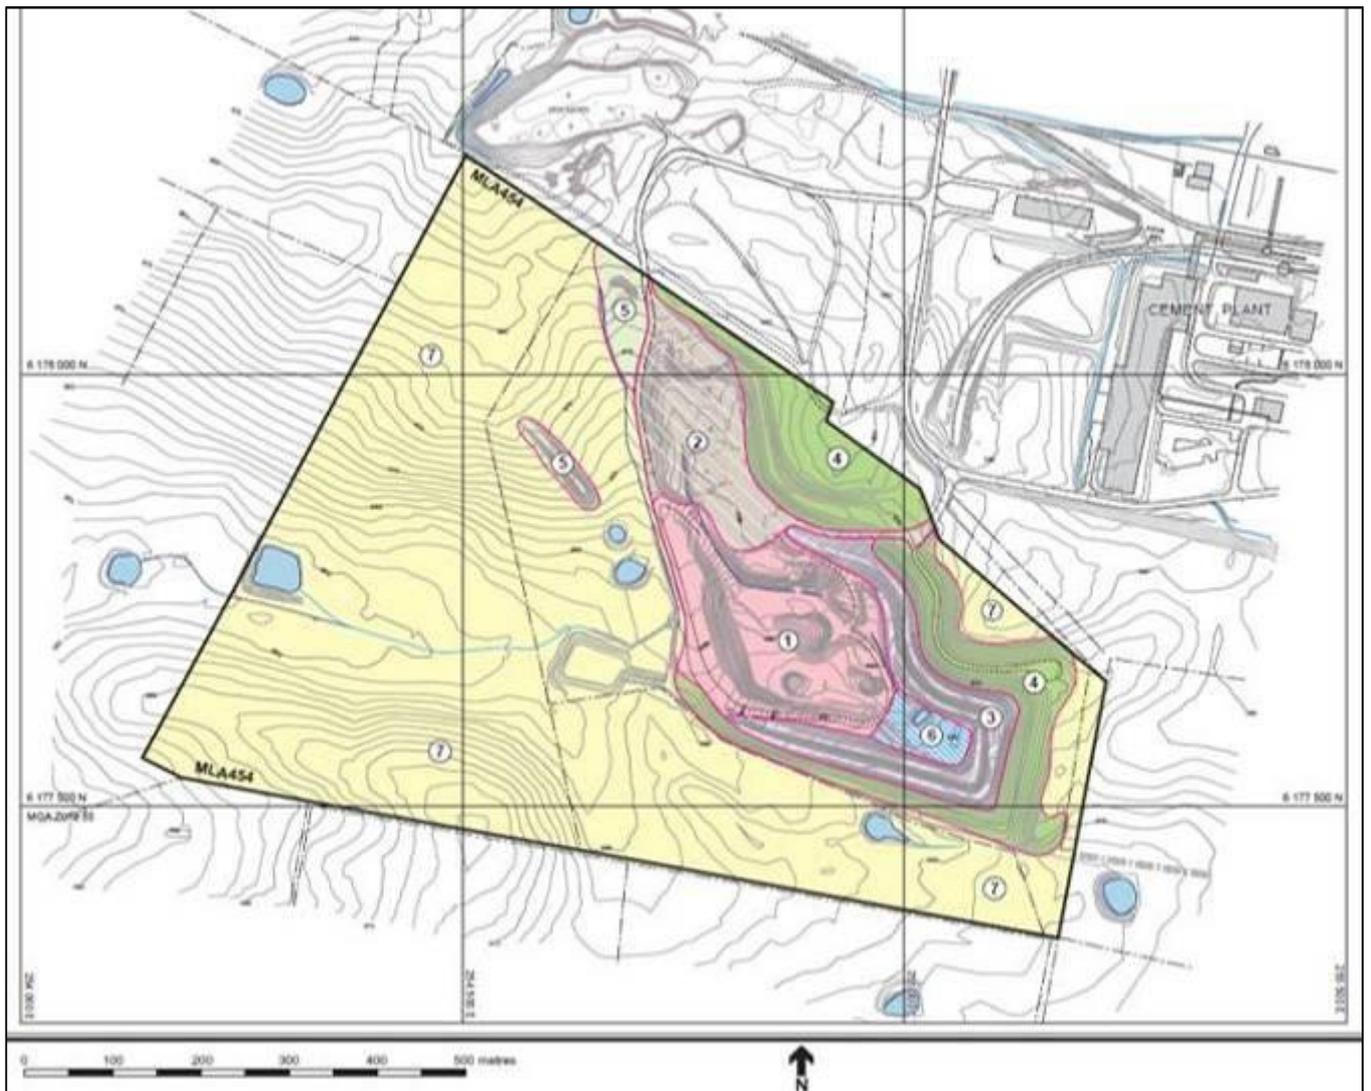
Map 3. Berrima Cement Works - Shale Quarry

The quarry has been divided into the following seven domains based on operational activities (Refer to Appendix A: Map 3):

During the 2019 Reporting Period, extraction continued to be conducted in Domain 1 (see Appendix A - Map 3) through a series of shallow benches by dozer ripping then pushing up the shale into stockpiles which were then loaded onto trucks for transport to the storage shed.

MINING DOMAINS

- Domain boundaries
- ① Active extraction area
- ② Unshaped material, storage areas and haul roads
- ③ Completed highwall awaiting rehabilitation
- ④ Completed rehabilitation subject to ongoing maintenance
- ⑤ Transitional rehabilitation (topsoil stockpiles)
- ⑥ Water storage
- ⑦ External areas

Shale extraction activities are proposed to continue from Domain 1 with a forecasted 140,000 tonnes during the 2020 Reporting Period (Refer to Appendix A – Map 3).

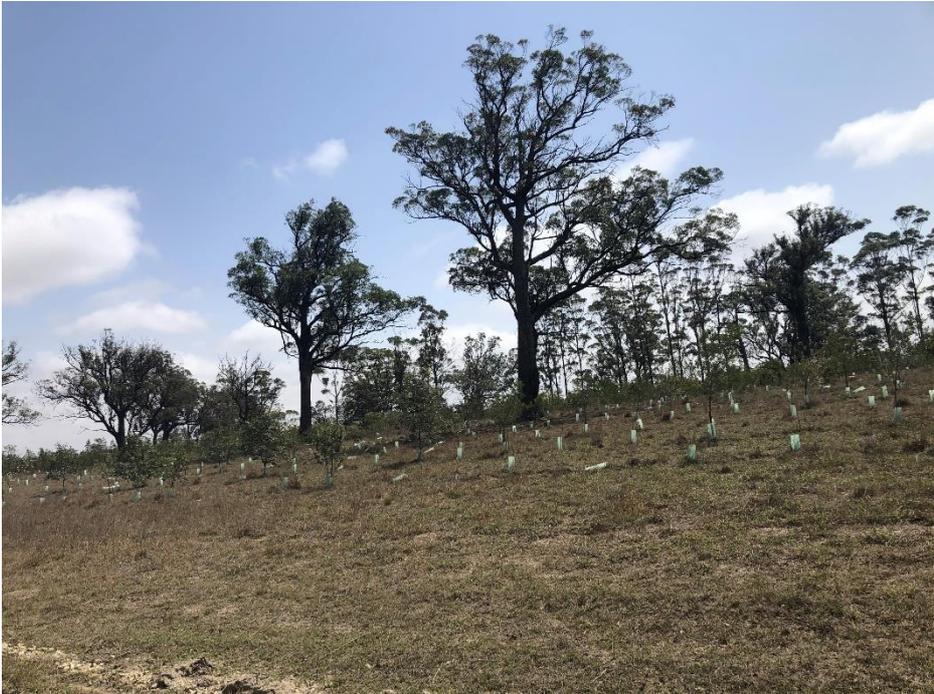
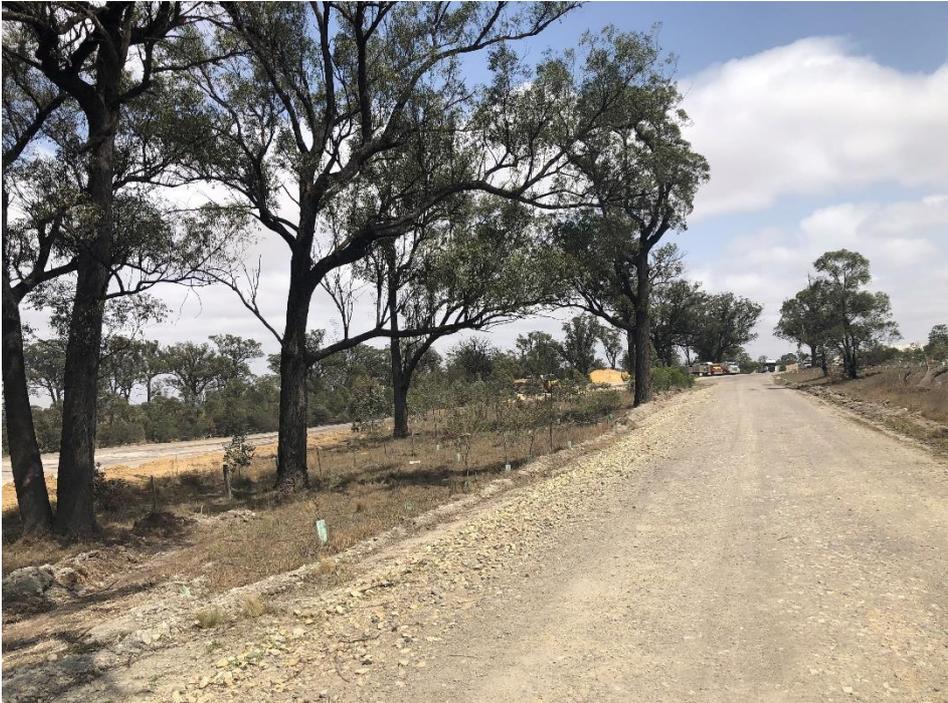
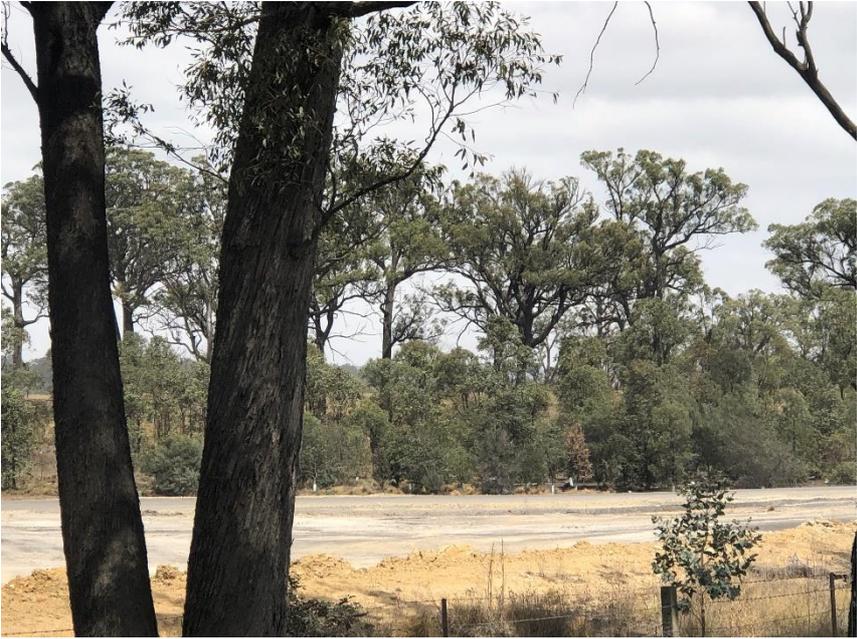
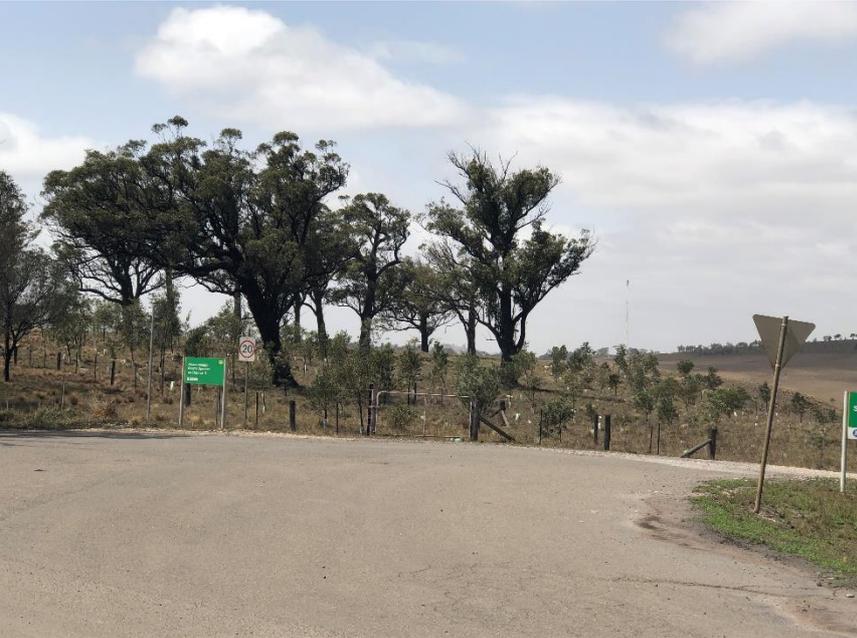
Photos 1a, 1b, 1c & 1d 2019 Domain Planting Northern Side of Quarry

Historic rehabilitation has concentrated on external bunding and disturbed areas not associated with ongoing extraction (refer to Appendix B: Photos 1 - 6). All of these areas have been previously rehabilitated and are now in monitoring and maintenance phase of the rehabilitation program detailed in the MOP. In between the quarterly Site attendances by the nursery contractors, the rehabilitation areas are periodically watered with the on-site watercart. The health and growth of plants within the rehabilitation areas remained strong throughout the 2019 Reporting Period (see Appendix B – Photos 1 to 6). Fortunately the drought conditions experienced during the reporting period has not impacted the previously rehabilitated areas.
