**Marulan South Limestone Mine**

**Boral Cement Limited**

**Annual Environmental Management Review**

**1 July 2022 to 30 June 2023**

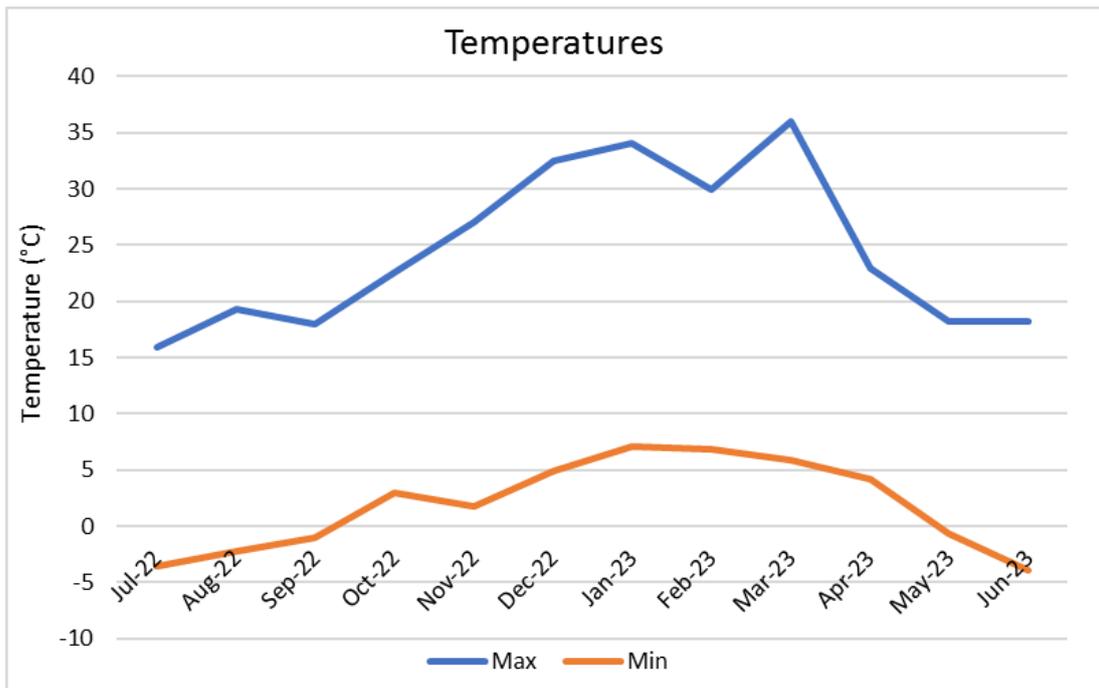
Jul	Aug	Sep	Oct	Nov	Dec	Jan	Feb	Mar	Apr	May	Jun
Max	15.97	19.32	17.97	22.52	27.03	32.48	34.08	29.9	36.04	22.87	18.24	18.17
Min	-3.57	-2.24	-1.03	2.98	1.78	4.86	7.12	6.85	5.88	4.16	-0.68	-3.92

**Graph 6.2 – Monthly Minimum and Maximum Temperatures**

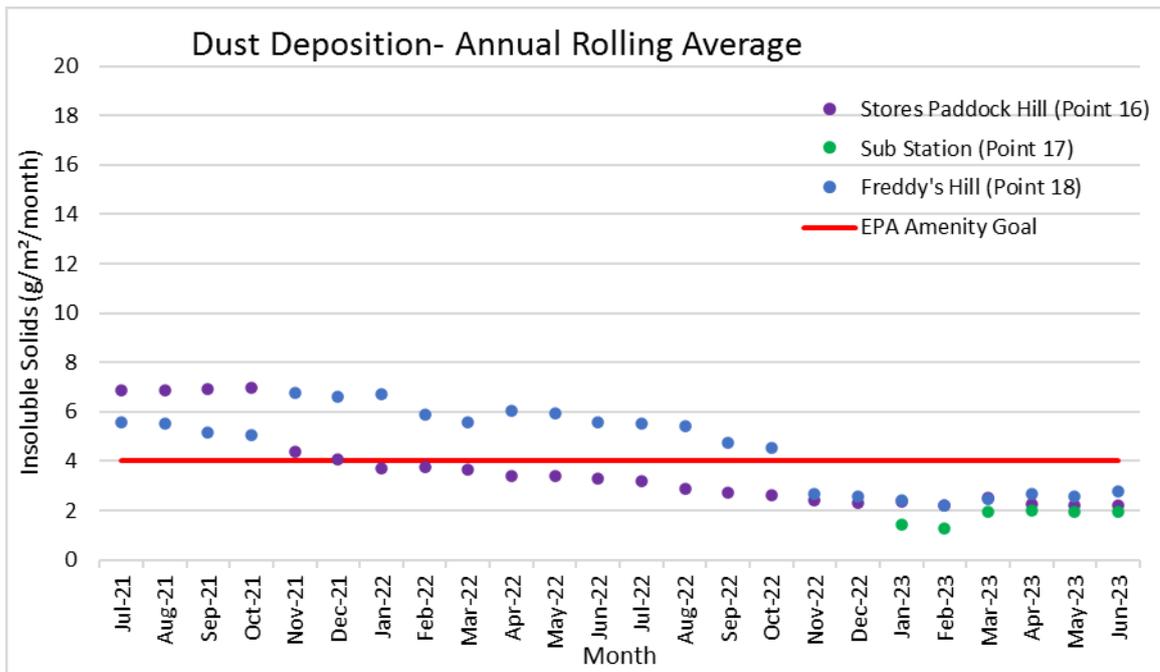
The data from the Sub Station was collected from January 2023 and the EPL was varied in March 2023 to include this gauge. The results remained consistently below the EPA amenity criteria guidelines with an average of 1.95g/m<sup>2</sup>/month for the six months to June 2023 (Graph 6.3).

**Graph 6.3 - Rolling Average Dust Deposition at EPL Points 16, 17 and 18**

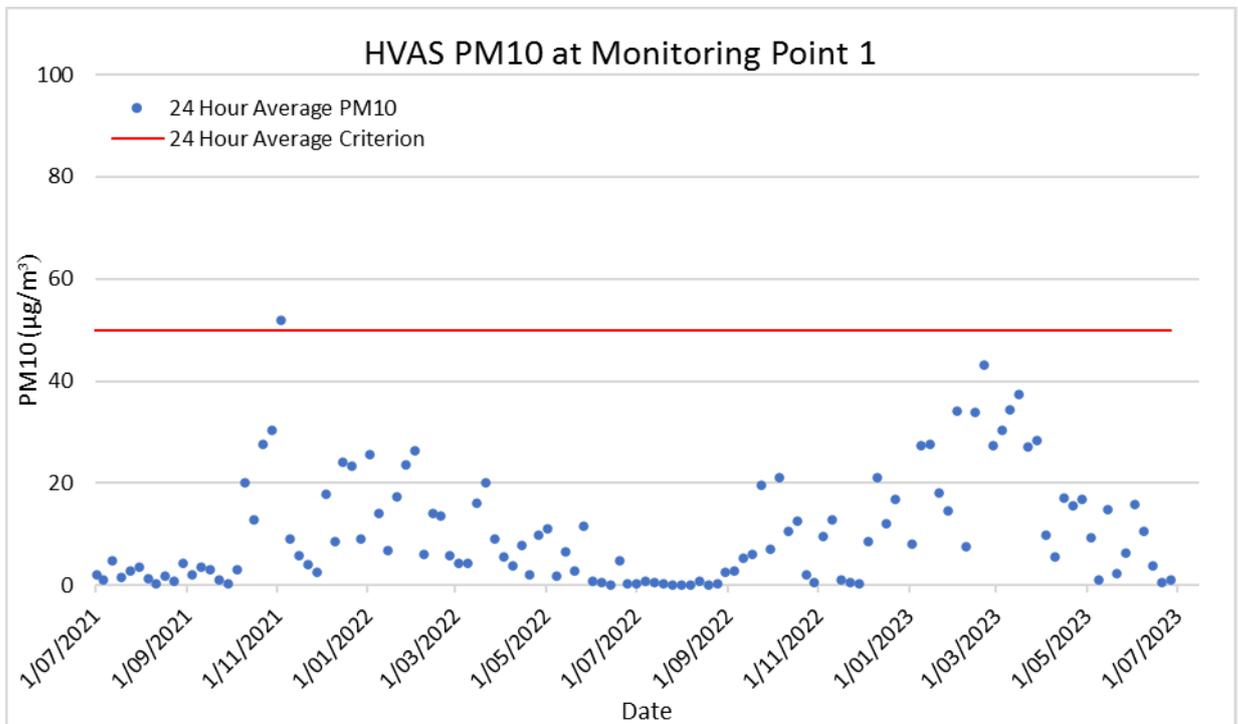
The PM<sub>10</sub> high volume air sampler (HVAS) is referred to and located at the 'Nearest Resident' and identified as Monitoring Point 1 in the EPL. The monitoring results for the reporting period and the previous period are shown in Graph 6.4. The 24-hour average PM<sub>10</sub> indicated that there were no exceedances of the 24-hour average EPA amenity criteria during the reporting period and only one exceedance since monitoring commenced. The annual average during 2022-23 reporting period was 11.8 µg/m<sup>3</sup> which is well below the annual criterion of 25 µg/m<sup>3</sup>.

**Graph 6.4 - PM<sub>10</sub> Monitoring Point 1 HVAS**

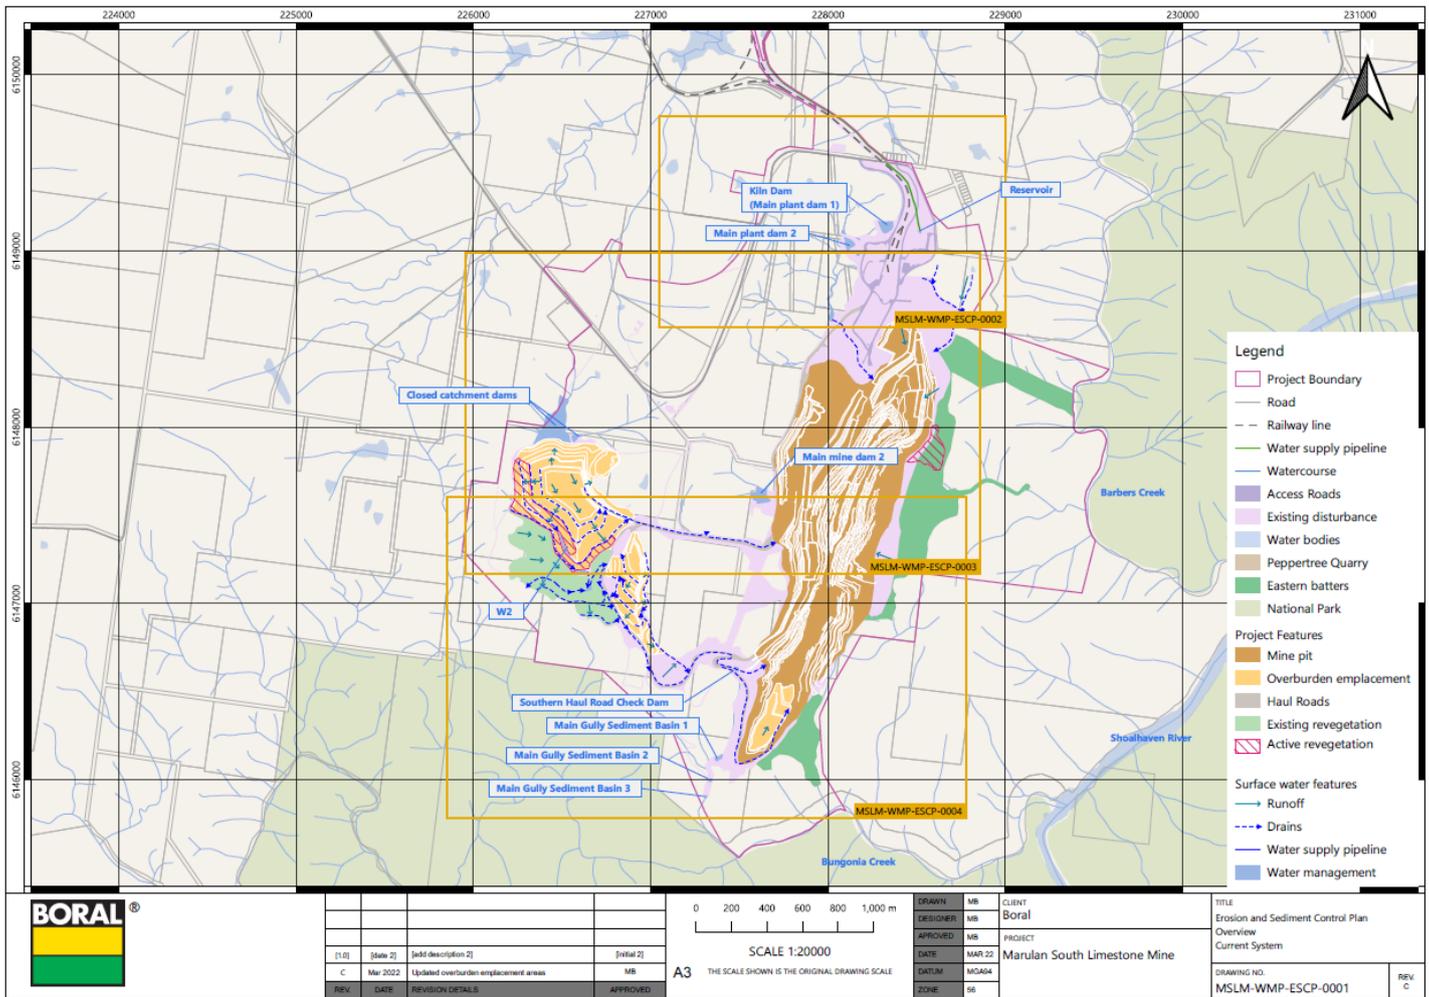
An overview of the current water management plan is provided in Plate 1.

**Plate 1 – Existing Surface Water Management System**

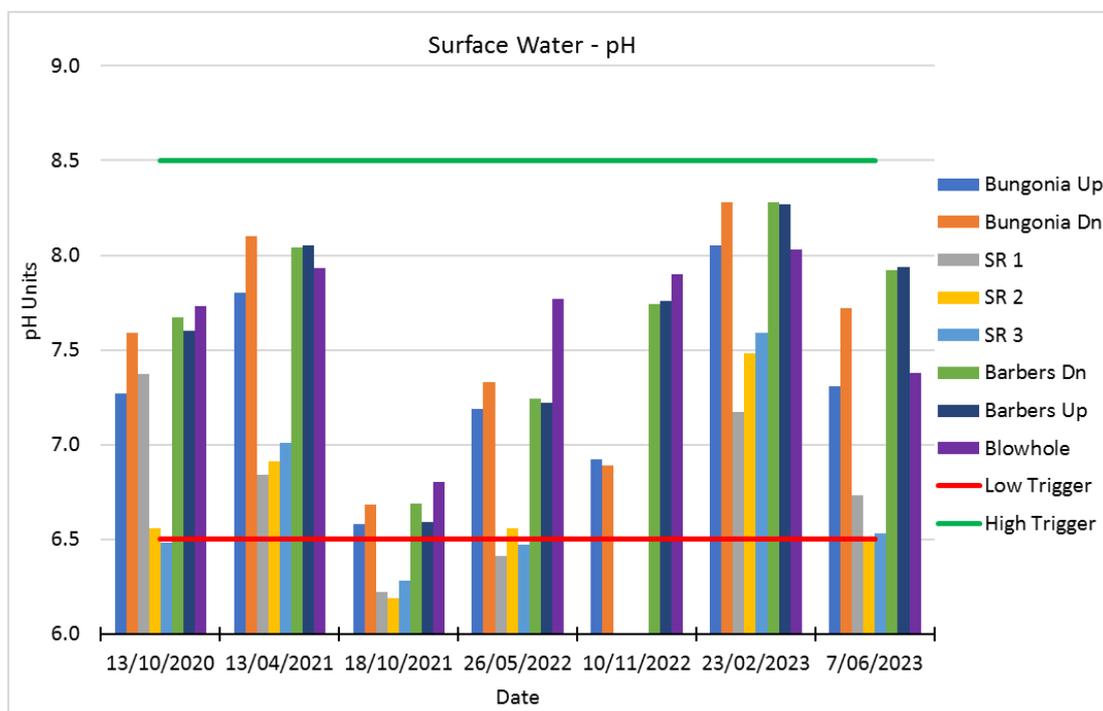
Surface water trigger values have been outlined in the Water Management Plan and are noted in Graphs 7.1 - 7.6 below. The purpose of the trigger values is to provide indicators of whether the mine is having an influence on the receiving water quality. Graphs 7.1 - 7.6 present the water quality parameters over the last two reporting periods.

**Graph 7.1 – Ambient Surface Water Quality – pH**

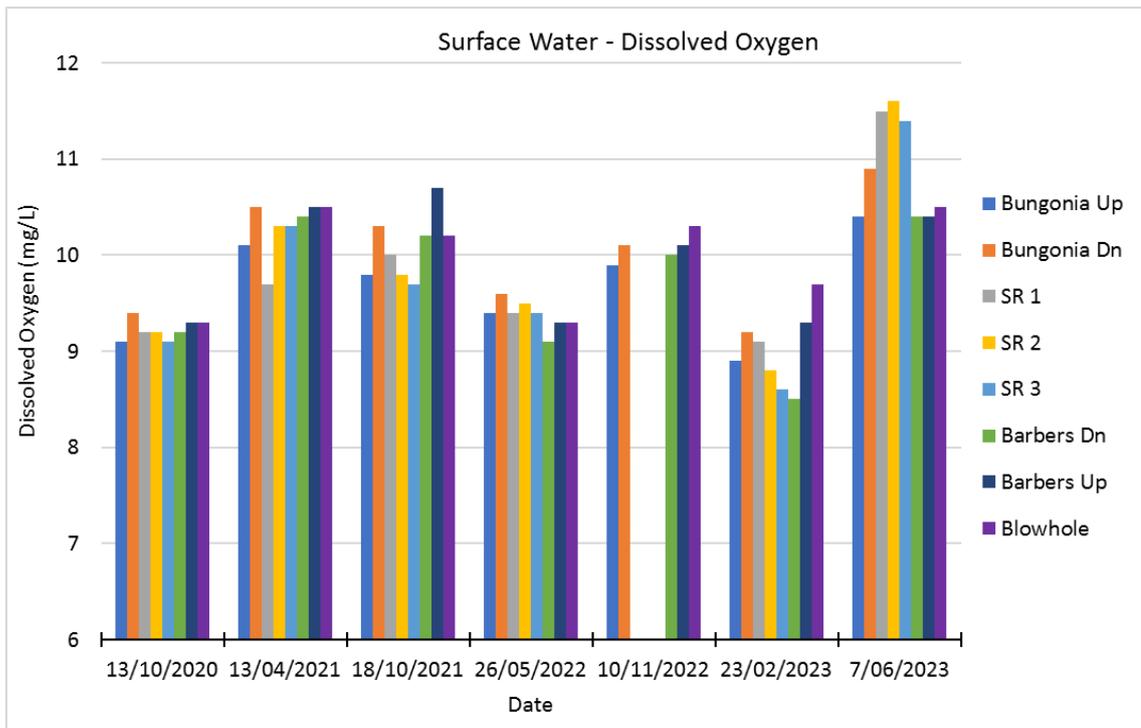
**Graph 7.3 – Ambient Surface Water Quality – Dissolved Oxygen**

The dissolved oxygen levels range from 8.5 mg/L to 11.6 mg/L with an average of 9.84 mg/L over a three-year period across all ambient surface water monitoring sites (Graph 7.3). Results show that the waterways have sufficient dissolved oxygen levels to support a healthy aquatic environment including fish populations.

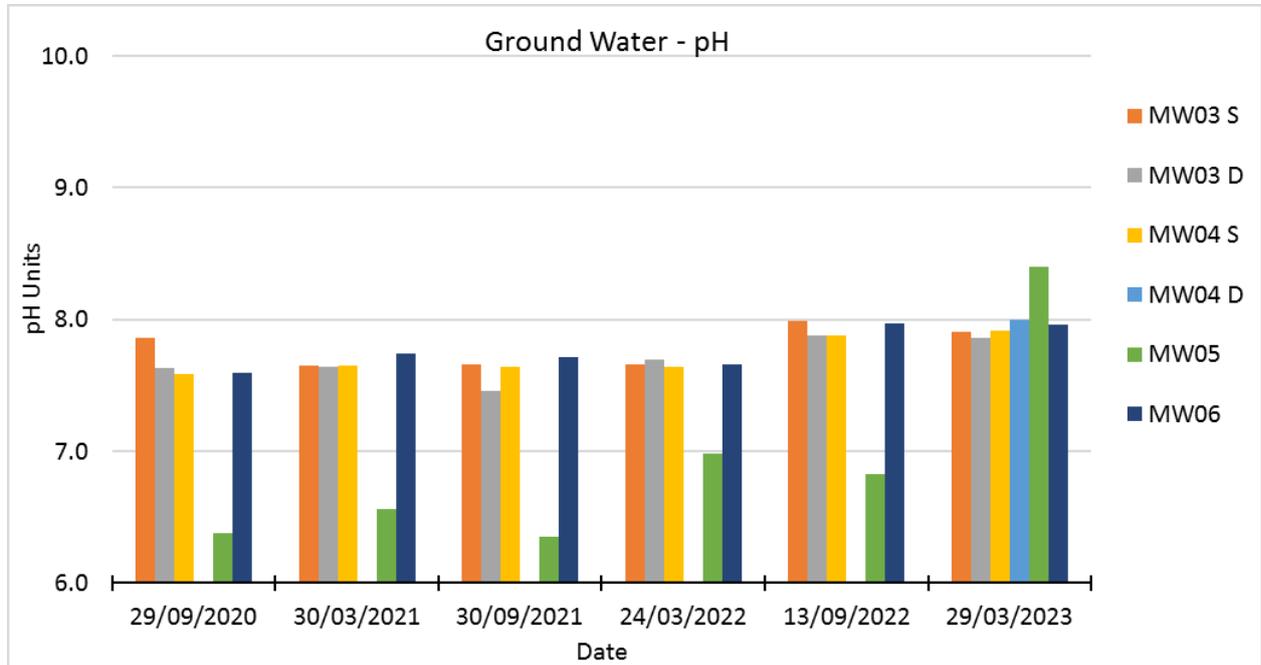
**Graph 7.7 – Monitoring Bore Ground Water - pH**

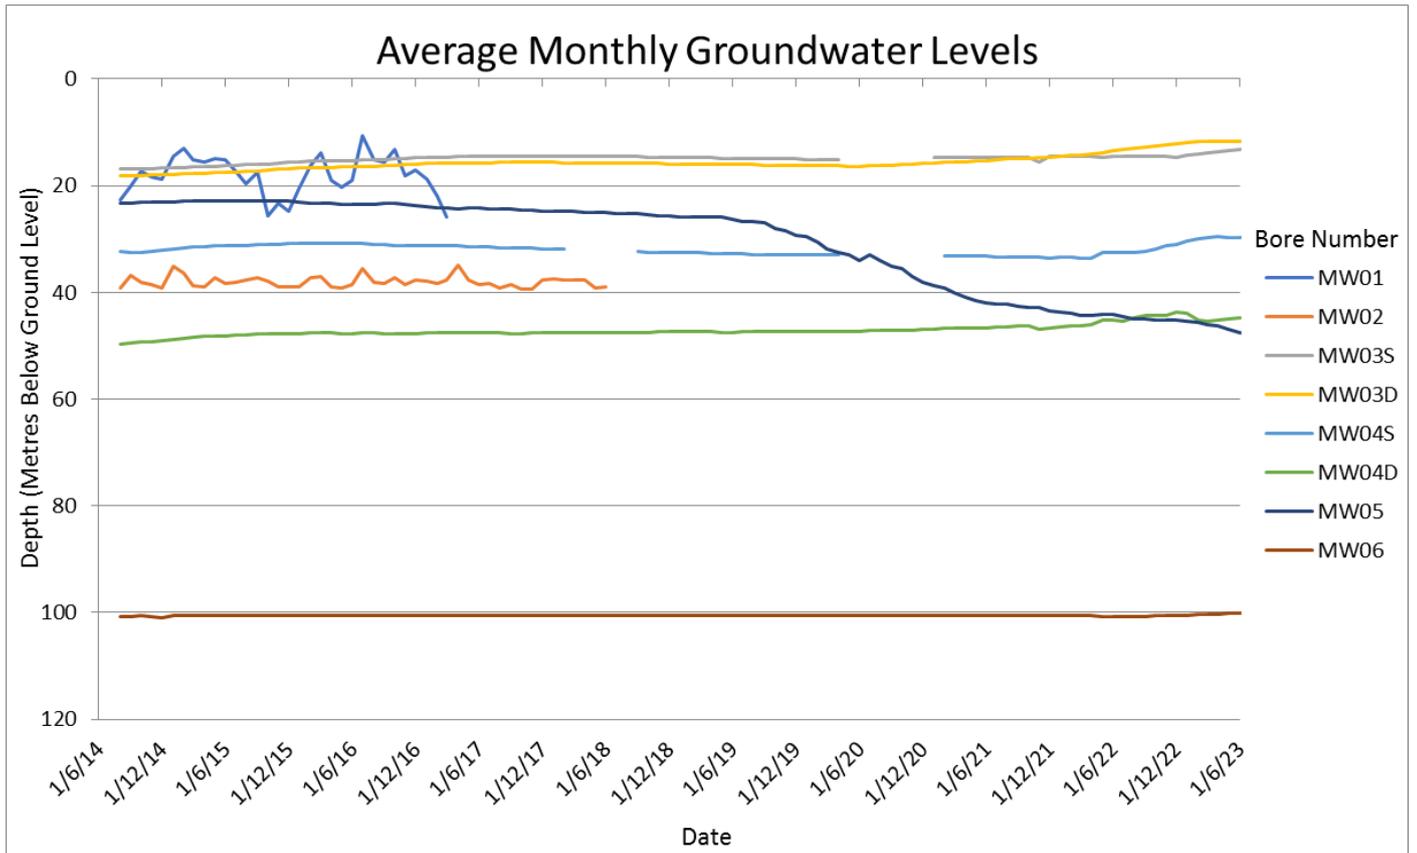
The standing water level in monitoring bore MW05 presents a gradual decline from March 2017 until May 2019, then a much more rapid decrease from June 2019 until present. The decrease in standing water level observed at MW05 was expected based on groundwater modelling predictions of pit development. It is believed that the rapid decline was a result of the removal of the cross-cutting dolerite dyke in the North Pit which appeared to be 'damming' groundwater up-dip. Since the water level of this bore is artificially high (perched) it is also not reflective of the impact the quarry is having on regional groundwater levels. MW03 and MW04 are more accurate representations of the surrounding granite groundwater systems which have not as yet been impacted by the limestone removal within the mine. Graph 7.9 below shows that bore levels as monitored since 2014.

**Graph 7.9 – Average Monthly Groundwater Levels from Monitoring Bores**

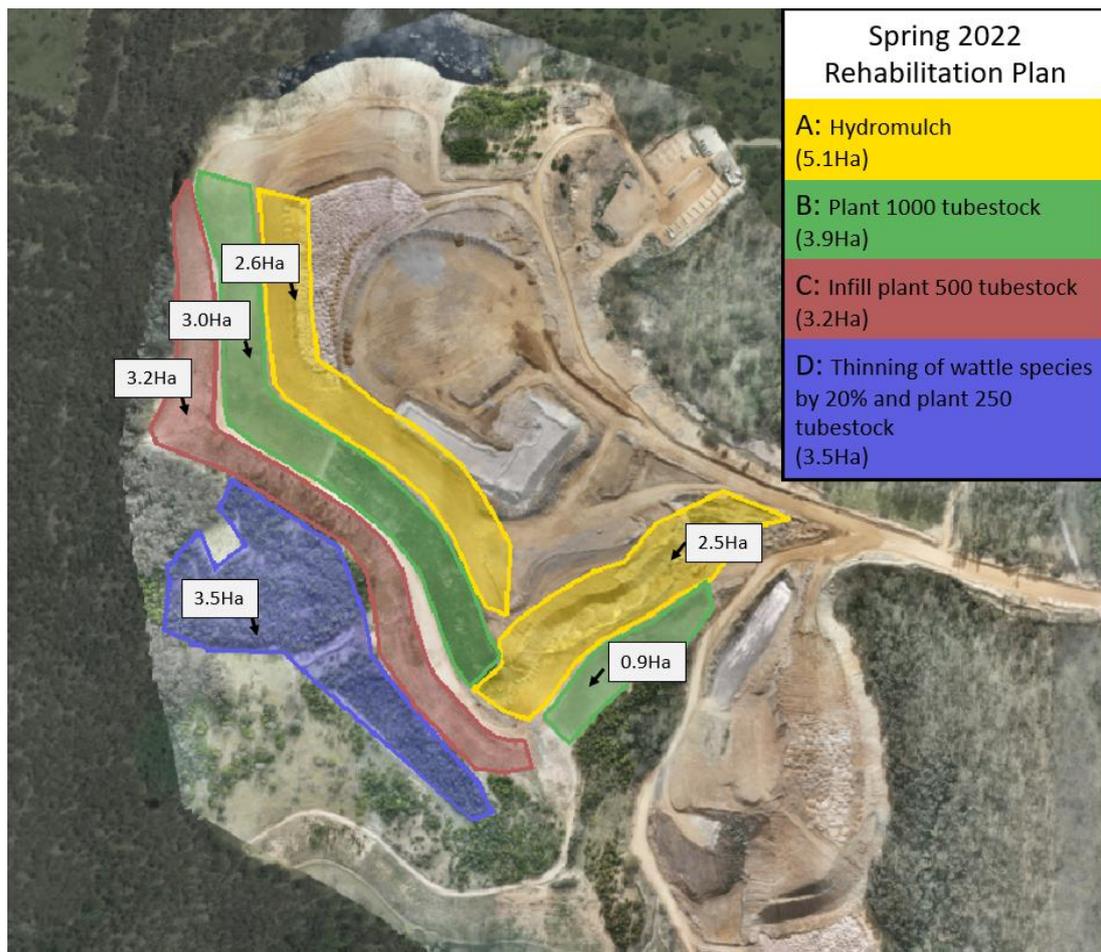
Rehabilitation works during the reporting period have focused on the second highest bench of the Western Overburden Emplacement (WOE) as per the Rehabilitation Plan in Plate 1. Flexterra FGM with ryegrass and couch cover seed mix (Table 8.3) was selected from the previous hydro-seeding trials to rehabilitate 5.1ha of the Western Overburden Emplacement during Spring 2022 (See Plate 2 below). The hydro-seeding conducted in Spring was deemed to be extremely successful, with close to complete groundcover by the end of June 2023.

Plate 1 Western Overburden Emplacement Rehabilitation conducted in Spring 2022

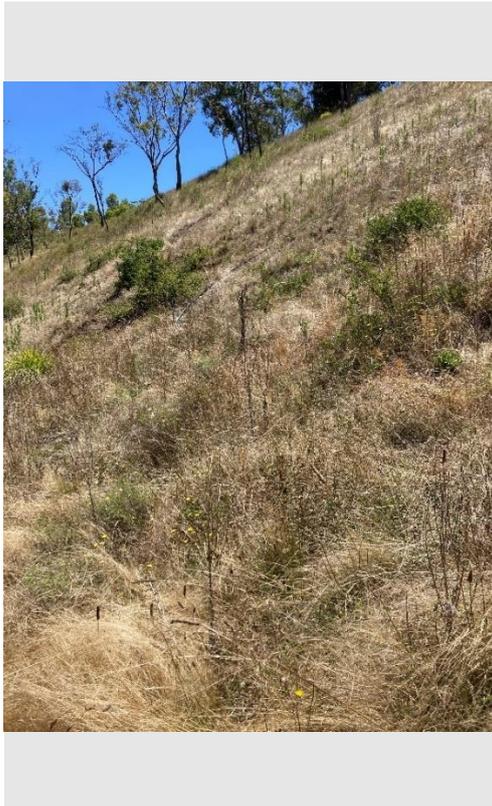
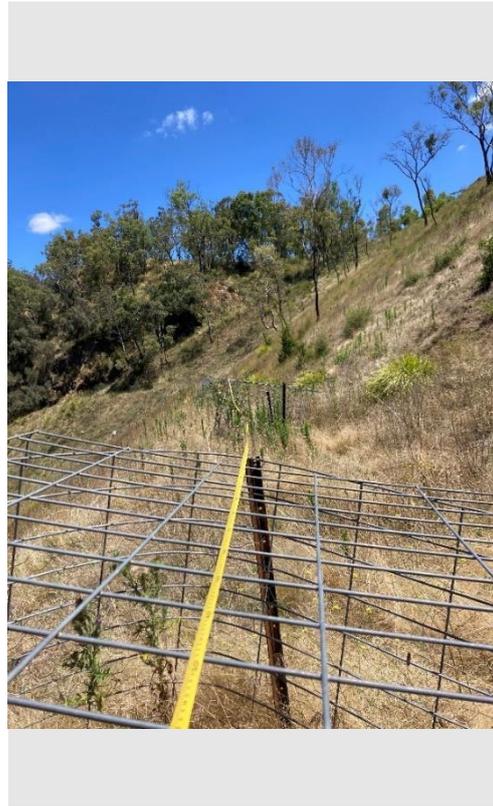
**Plate 3 Current status of Bryces Gully bench 2 (EFA site 4) January 2023**

Inspections during January 2023 showed that regeneration is going well on the upper benches with the tube stock becoming more established (Plate 3). Low levels of loss were recorded, and thus replacement of tube stock has not yet been required. Further down the slope in the narrower sections of the gully there has been less success with the species planted due to wetter conditions and less light and alternate replacement species such as sandpaper fig will be investigated in the coming period.

Future rehabilitation work on Bryce's Gully will likely include additional planting of tube stock within new rehabilitation enclosures on the lower section of the gully (See Plate 4), spot spraying and replacing of tube stock where necessary.

A Geotechnical report on Bryce's Gully was completed during the reporting period which deemed the slope unstable at this time (See Section 6.11). It was advised that personnel should avoid entering this area as it may not be safe. Rehabilitation works planned for the 2023-2024 reporting period have been put on hold until actions can be put forth to ensure slope stability.

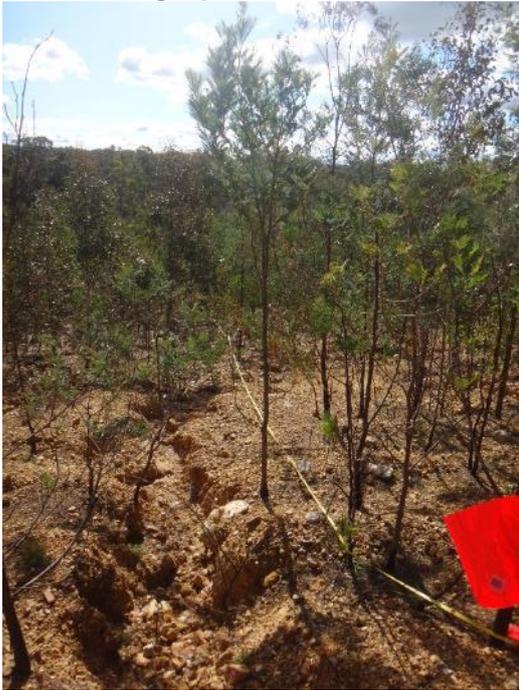
July 2020

Monitoring of Site 1 was discontinued in April 2021 due to the proposed expansion of the Western Overburden Emplacement.

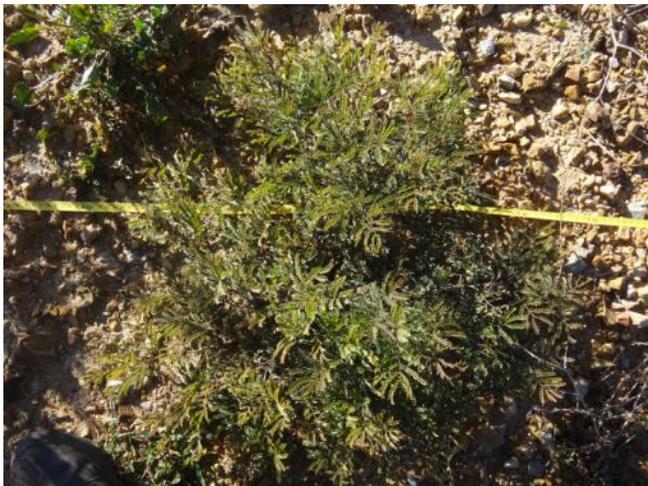
Shrub (S) patches ranged up to 1.5m in height and were characteristic of native plant growth. This category also includes native juvenile tubestock.

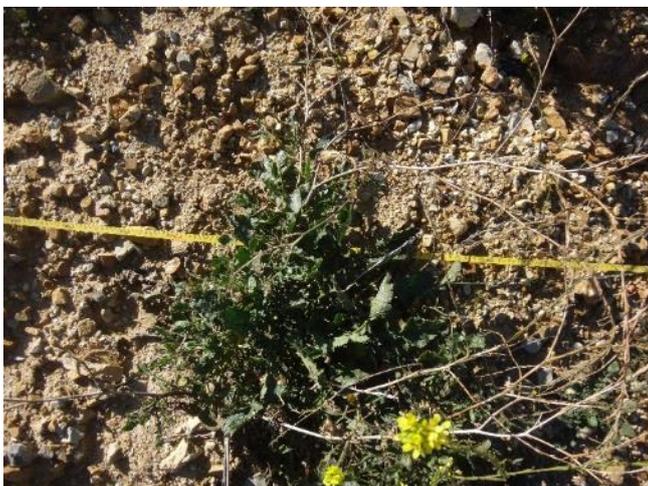
Weed (W) comprised individual and thickets of exotic species which were not planted during rehabilitation.

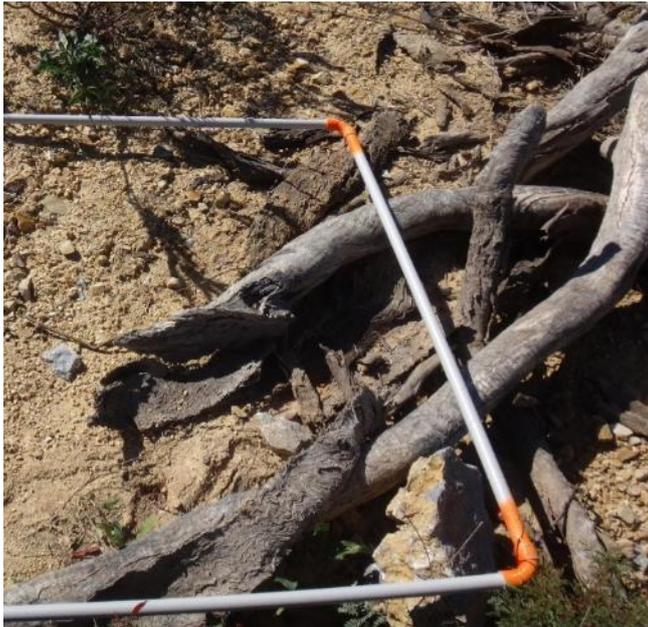
Niche (N) patches included fallen logs, piles of bark and debris which can enhance habitat structure.

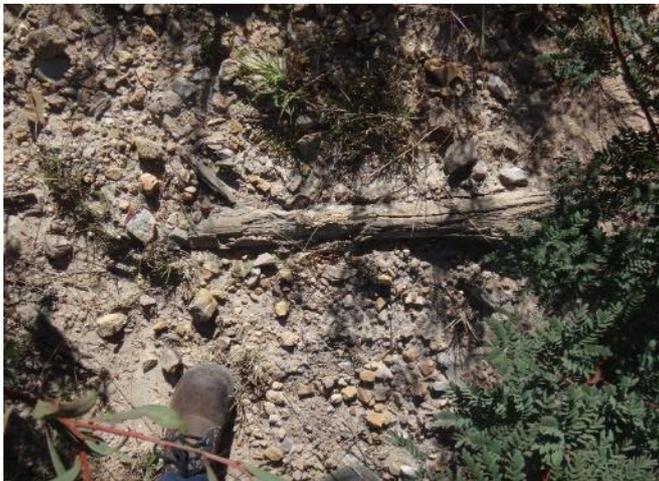
A Log (L) patch differs from a Niche, as it includes a single log, often partially buried in the soil which has not accumulated additional debris, as in T5.

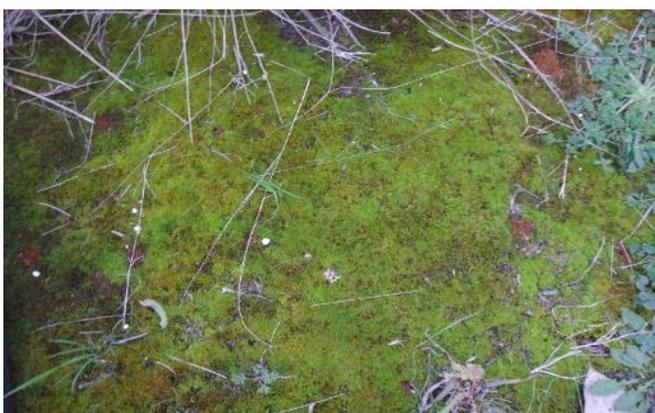
Patches of moss (M) have been present in T2, T4 and the reference site

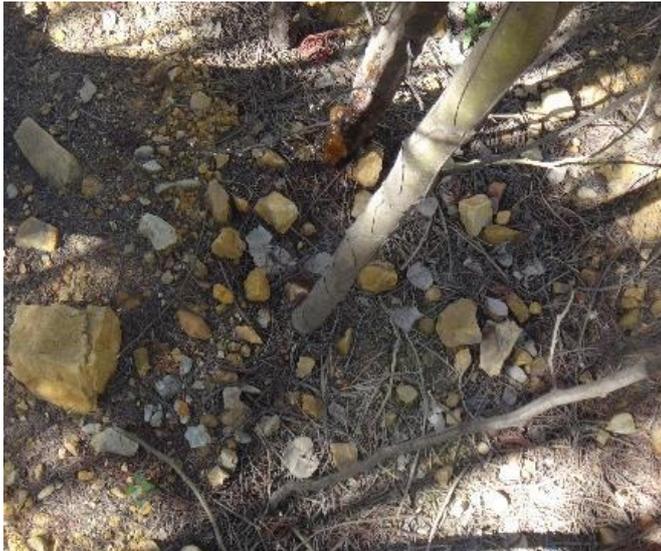
Leaf litter (LL) varied from Acacia leaves, Eucalypt leaves, small branches and dead and decomposing tussock grass in T4.

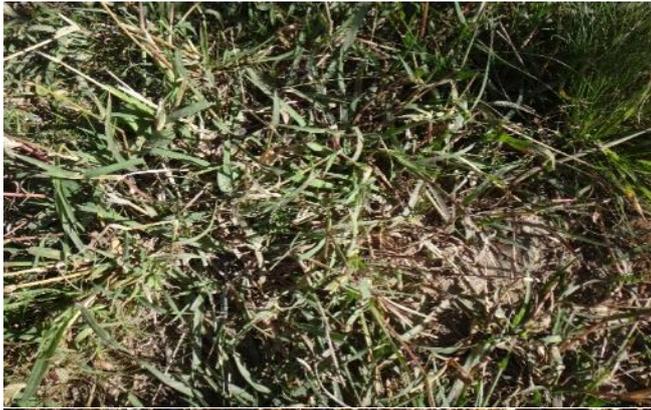
Grass patches (G) were observed at all rehabilitated sites. These patches were often reflective of improved pasture species which had been sown as a cover crop.

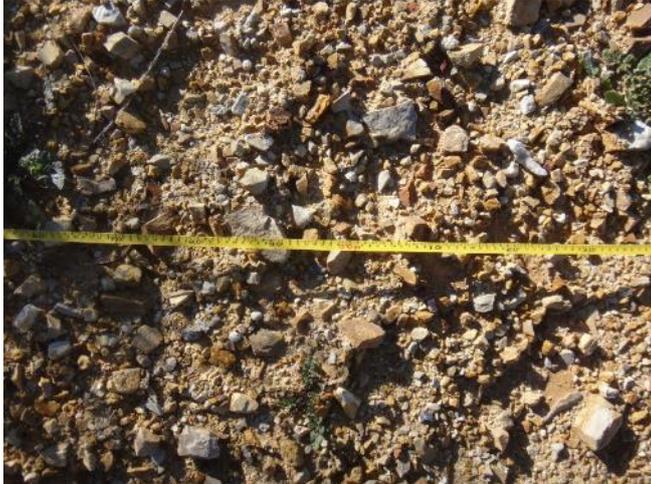
Bare ground (BG) is an interpatch type which consists of overburden material. A high composition of rocks is evident and hydro-mulching material has been added to the surface to improve soil structure at some sites.

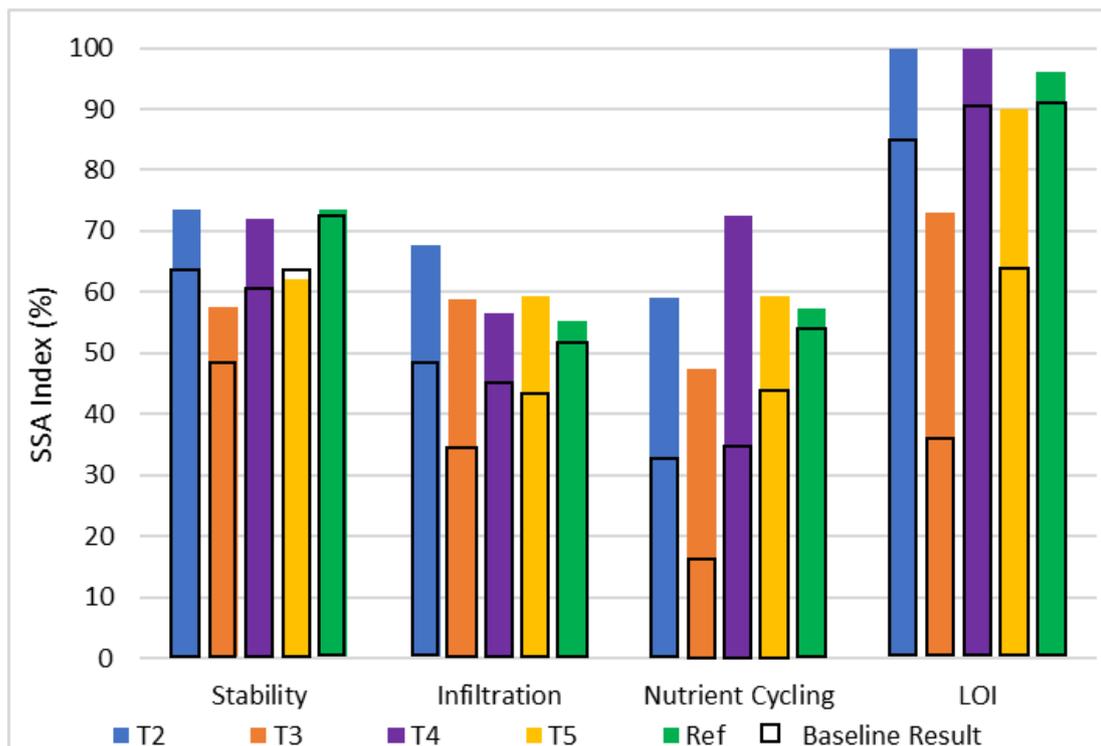
The LOI is a good indication of vegetation cover and is related to the SSA parameters. The proportion of bare ground is now negligible at all sites apart from Site 3 due to increased native ground cover, annual weed growth and increase leaf litter. Although improvements have been observed at Site 3, it is recommended that the LOI is improved to reach a similar score to the reference site (Graph 3). This can be done by minimising the proportion of bare ground on the site by increasing vegetation cover through planting and seeding methods.

**Graph 3- Soil Surface Assessment Index (%)** Baseline result= July 2020 (April 21 for T5)

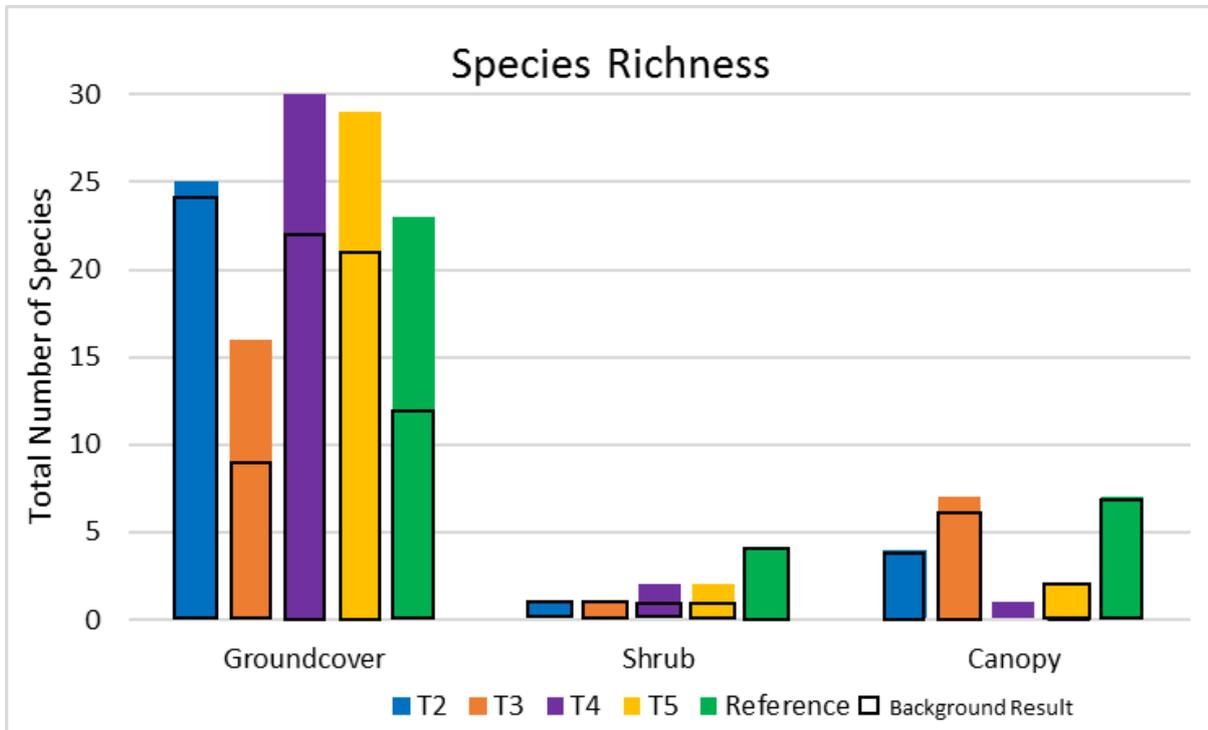
monoculture of *Acacia* trees does not reflect the natural reference site, and more care should be taken with species selection. It is suggested that planting of *Eucalypt* tubestock in these areas would improve diversity and species richness of canopy species to represent the reference site. This could be done progressively as the short lived *Acacias* naturally die off.

**Graph 4- Species Richness at three levels of vegetation strata** Baseline result= July 2020 (April 21 for T5)

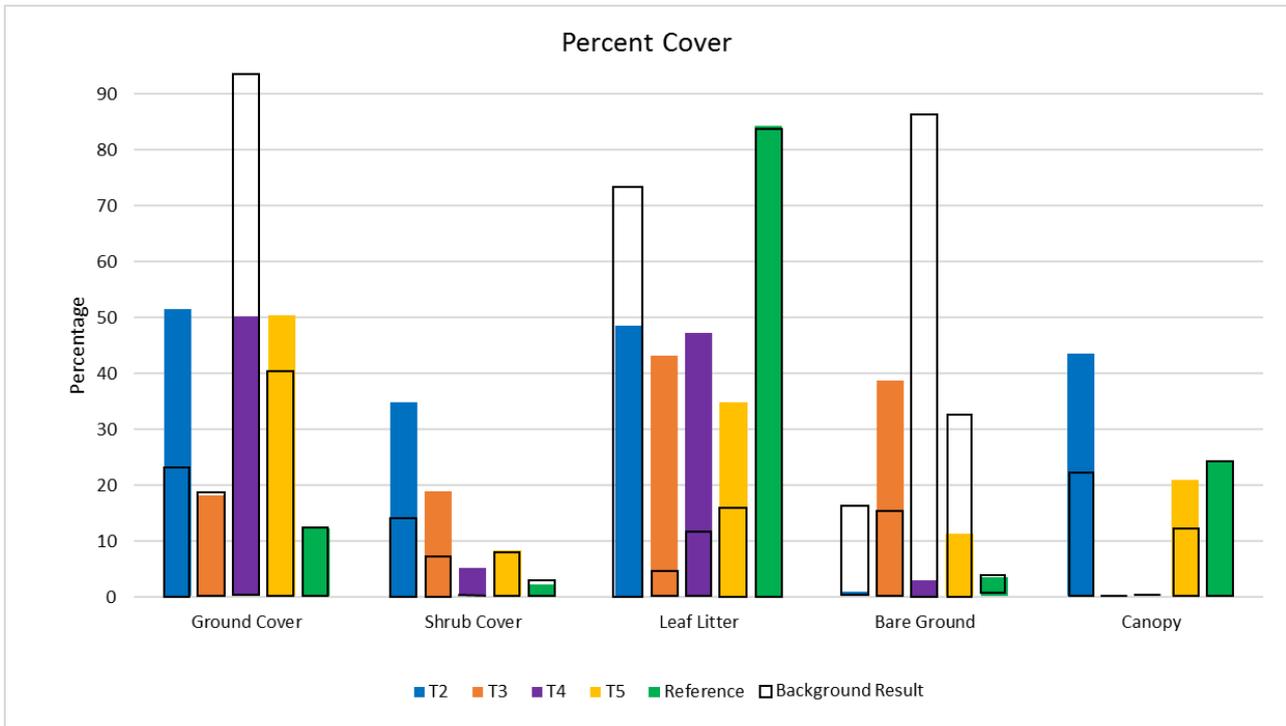
It appears that over the past 6 months there has been a reduction in bare ground across all the rehabilitated sites, as ground cover species emerge and the leaf litter layer develops further. The Landscape Function Analysis has deemed that the proportion of bare ground is not negligible at all sites excluding Site 3.

**Graph 5- Average ground, shrub, litter and bare cover percentages** Baseline result= July 2020 (April 21 for T5)

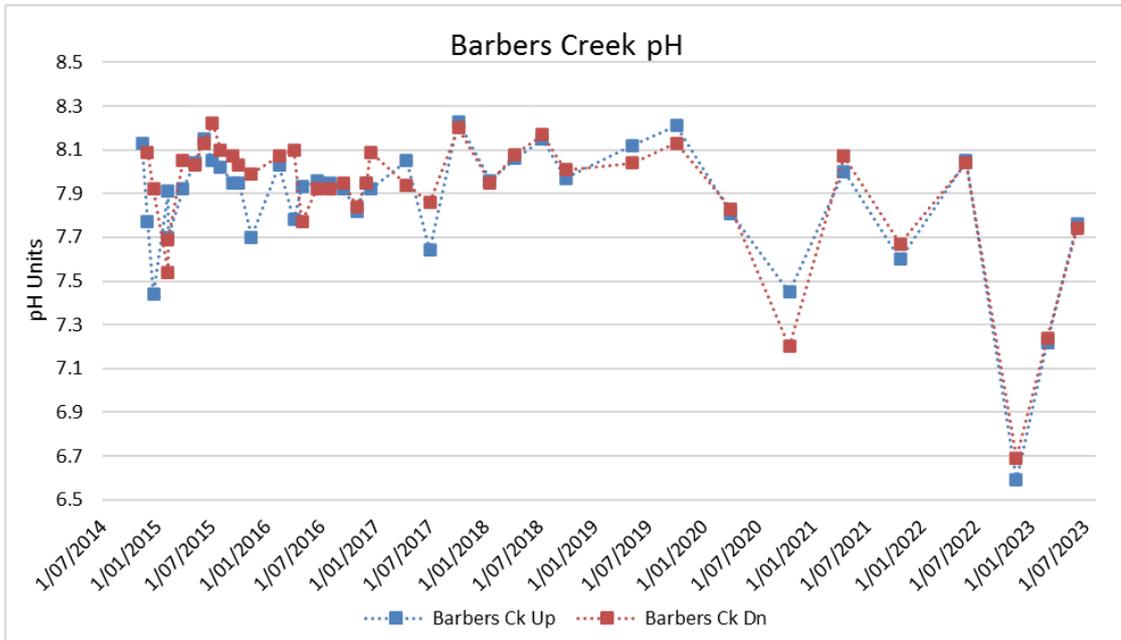
All of the creeks being monitored are sourced within limestone bedrock systems. Although limestone is naturally alkaline, fast flowing surface water from high rainfall events would not allow sufficient time to raise the pH in normally neutral precipitation. Flow rate and duration of contact with limestone is the main factor affecting pH.

**Figure 1- Barbers Creek upstream and downstream pH**

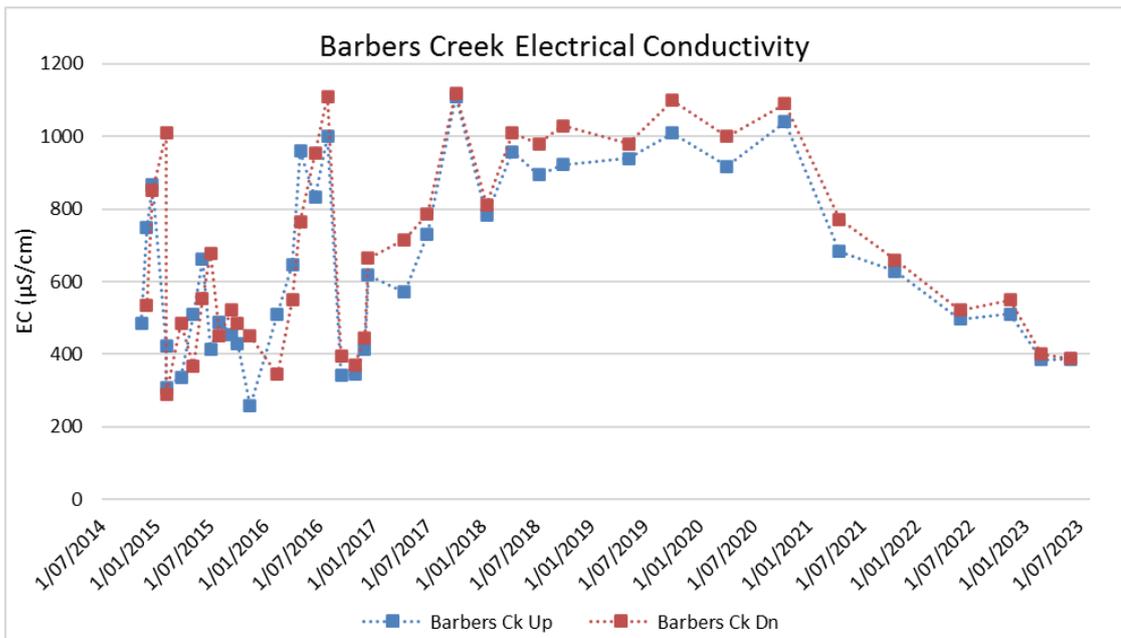
The electrical conductivity levels in Barbers Creek have fluctuated from 257  $\mu\text{S}/\text{cm}$  to 1120  $\mu\text{S}/\text{cm}$  over the past 9 years as shown in Figure 2. The conductivity levels have remained similar at sites upstream and downstream during the same sampling periods. High levels of fluctuation were observed from 2014-2018 during drought conditions, which then plateaued at around 900  $\mu\text{S}/\text{cm}$  for two years until 2020. Following higher rainfall, there has been a continued drop in conductivity to levels of 400  $\mu\text{S}/\text{cm}$  which hadn't previously been recorded since late 2016.

**Figure 2- Barbers Creek upstream and downstream EC**

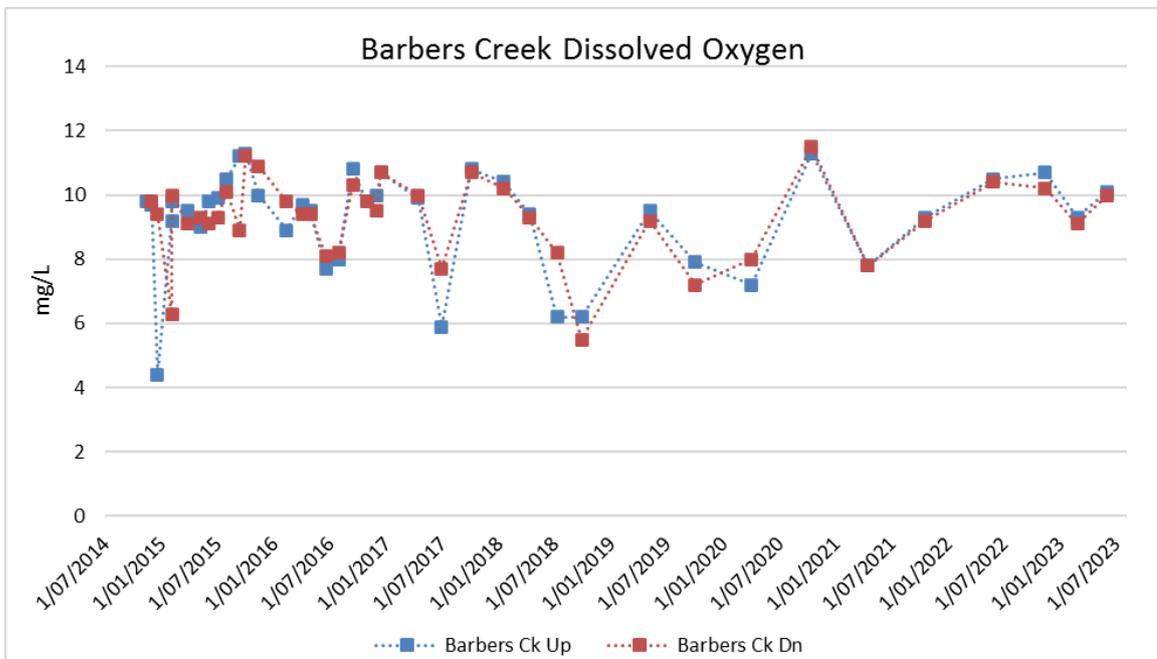
The dissolved oxygen levels in Barbers Creek range from 4.4 mg/L to 11.5 mg/L since 2014 (Figure 4). Samples taken from upstream and downstream sites have generally followed the same trend, with the same average of 9.3 mg/L at both sites.

**Figure 4- Barbers Creek upstream and downstream Dissolved Oxygen**

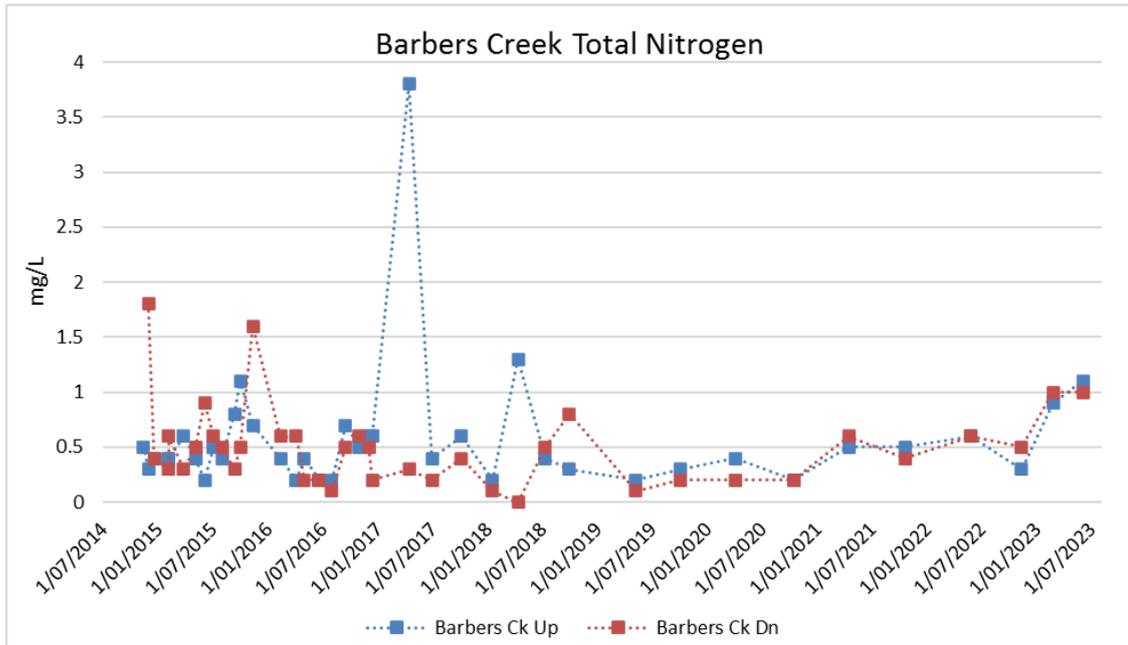
Nitrogen levels can be arbitrarily high at any point in time, particularly in small ephemeral creeks where a single dead animal can cause spikes in either Nitrogen or Phosphorus or both. If a spike appears, a comparison is made with other analytes such as dissolved oxygen to determine if there are any potential ongoing issues of concern. In this case, dissolved oxygen has remained generally between 6 and 11 mg/L which is indicative of a normal healthy river system.

**Figure 5- Barbers Creek upstream and downstream Total Nitrogen**

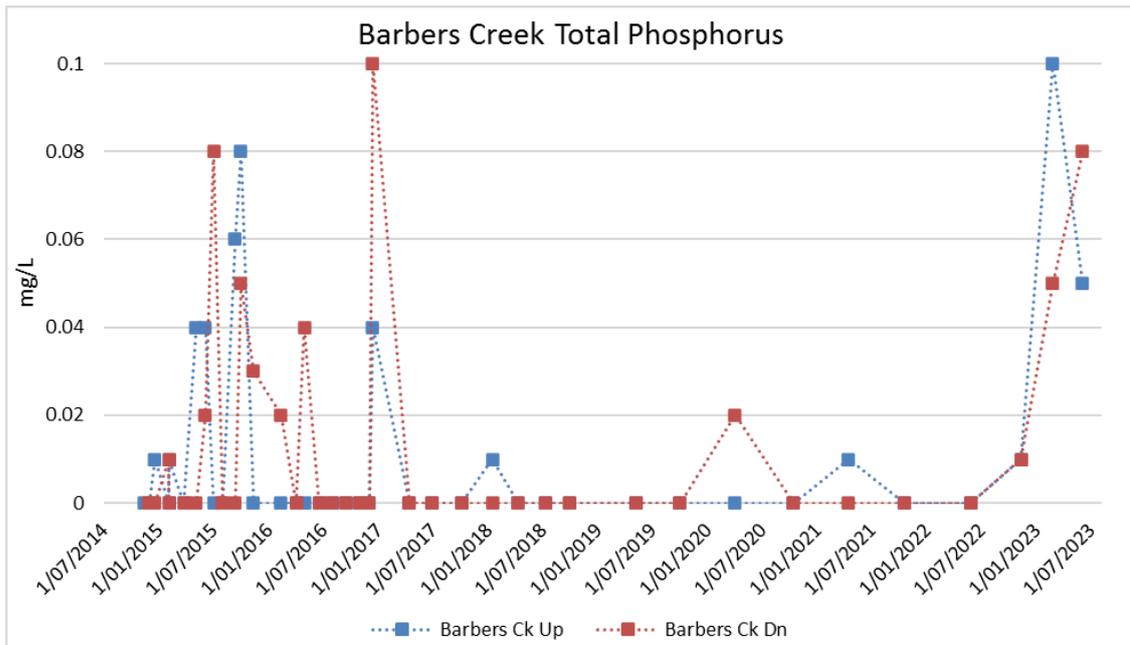
Phosphorus is as an essential nutrient for all plant and animal life, commonly as phosphate in inorganic fertiliser. Natural levels of Phosphorus have a similar range of between 0.01 to 0.08 mg/L. ANZECC guidelines place Phosphorus levels for natural rivers and streams at less than 0.1 mg/L. The levels found in Barbers Creek are within natural levels and do not indicate that there has been any contamination with fertilisers used in the rehabilitation work on the eastern emplacement and batter areas.

**Figure 6- Barbers Creek upstream and downstream Total Phosphorus**

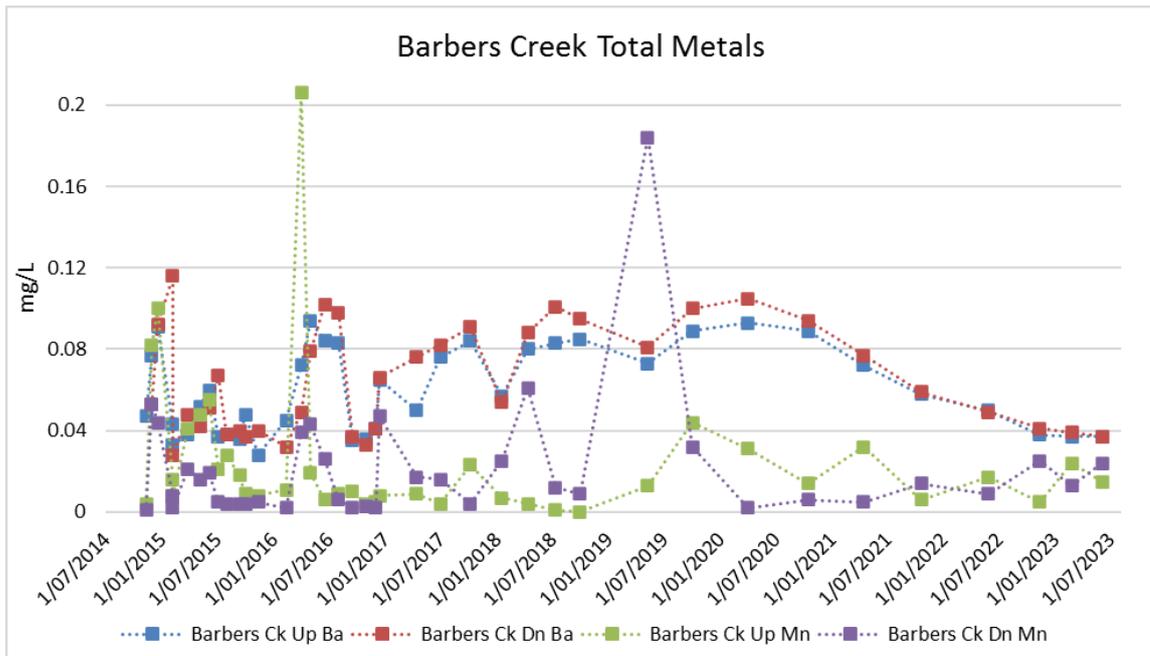
The use of fertilisers on rehabilitation areas is normal and it is expected to be detected in downstream water quality analysis. Short term spikes are not hazardous to normal environmental or riverine processes and have no lasting or ongoing impacts. However, excessive use of fertilisers can cause nutrient related impacts within receiving waters. This situation becomes impacting if the elevated levels are sustained over longer time periods which often is the case with streams draining active agricultural areas where regular fertiliser treatments result in continual leaching of nutrients.

**Figure 8- Barbers Creek upstream and downstream Total Metals (Barium and Manganese)**
