**Marulan South Limestone Mine**

**Boral Cement Limited**

**Annual Environmental Management Review**

**1 July 2022 to 30 June 2023**

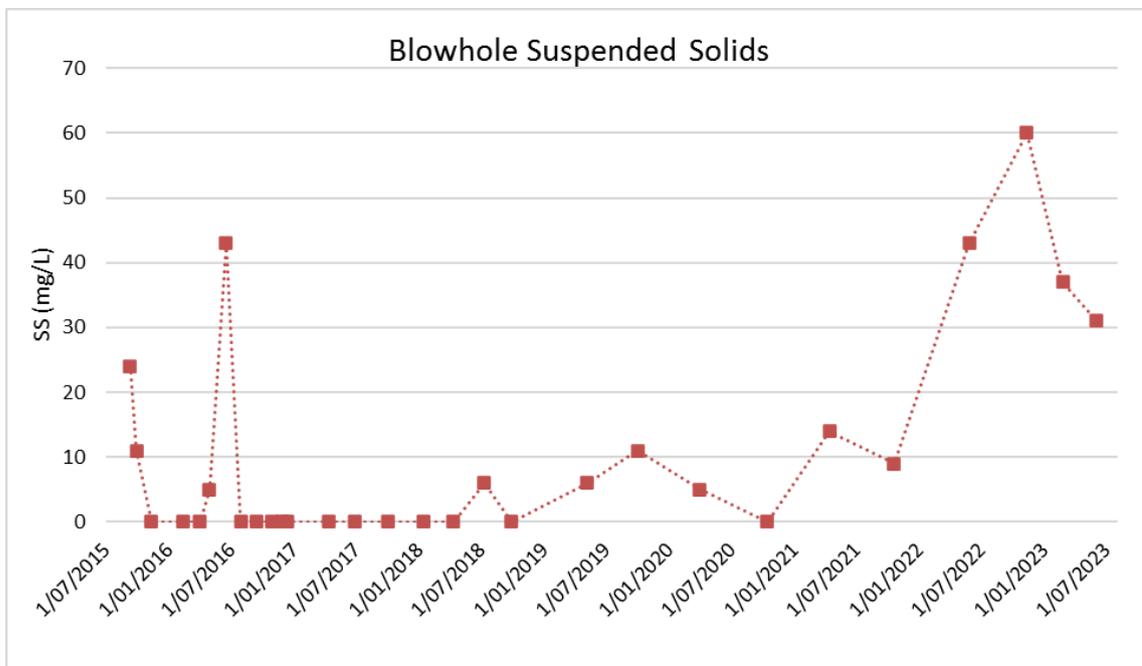
**Figure 19- Blowhole Suspended Solids**

The suspended solids generally remained below the detection limits (<5mg/L), with only a few outliers up until 2019 (Figure 19). Since that time, the levels have ranged between 6 mg/L to 60 mg/L, with an increasing trend since January 2022. During periods of high solids loading, the discharge has been noted as brown to orange in colour. This indicates the presence of elevated minerals.

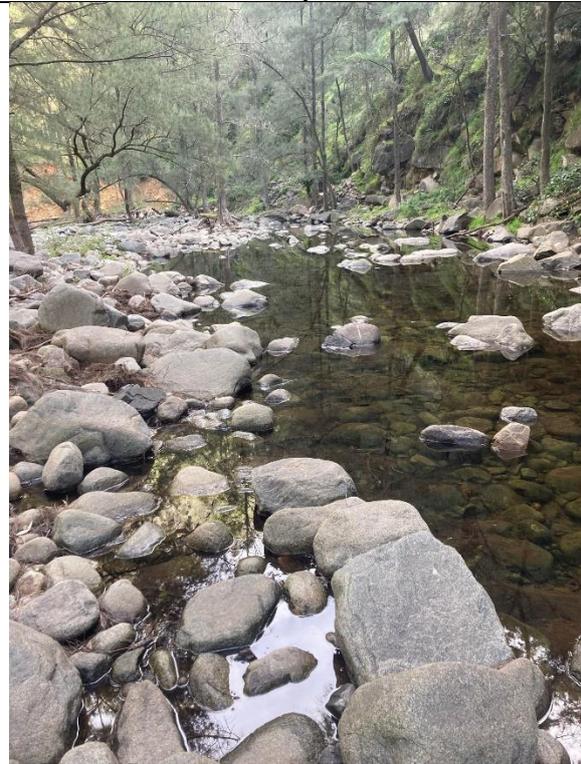
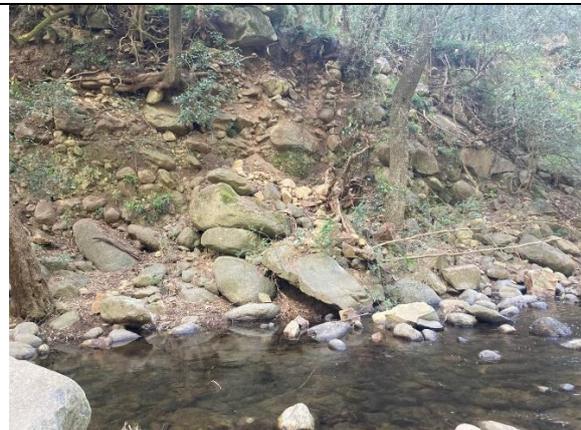
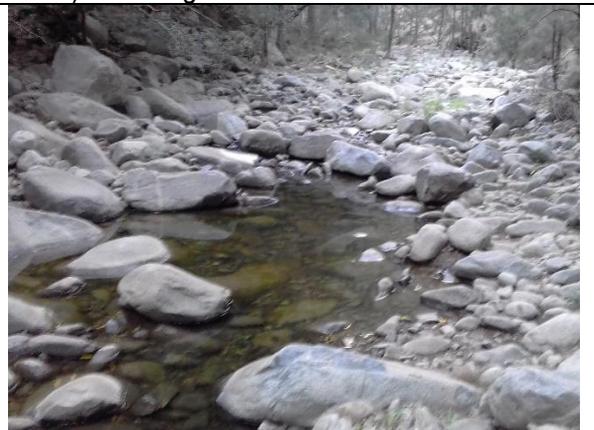
## Plate 1- Barbers Creek Upstream

Barbers Creek Upstream photos are provided in Plates 1 of Appendix A and Barbers Downstream photos are provided in Plate 2 of Appendix A. Barbers Creek is characterised by a rocky boulder channel with rock pools. The gradient of the channel ranges from 5% to 6%. Barbers Creek is a fifth order stream at the junction with the Shoalhaven River.

a) Looking downstream June 2023

c) Looking to northern bank June 2023

d) Looking upstream May 2019

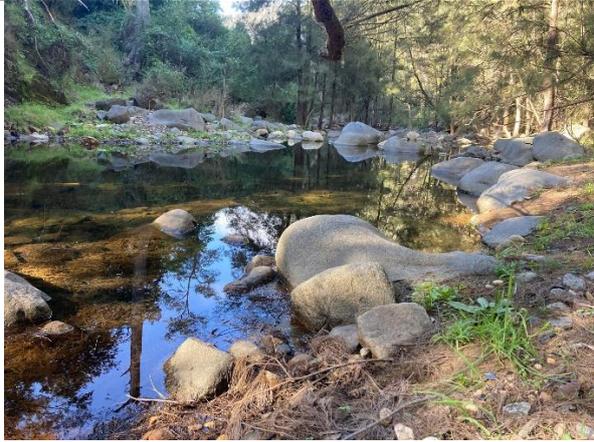
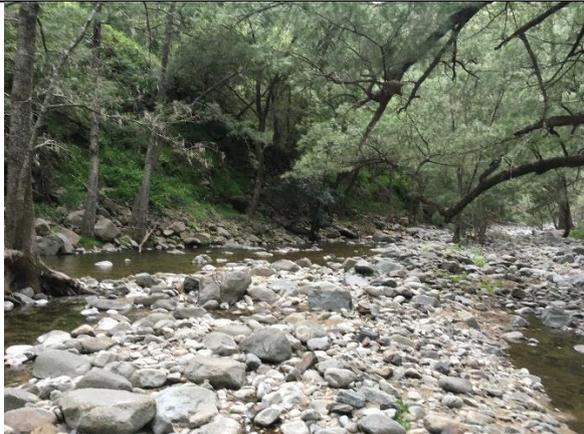
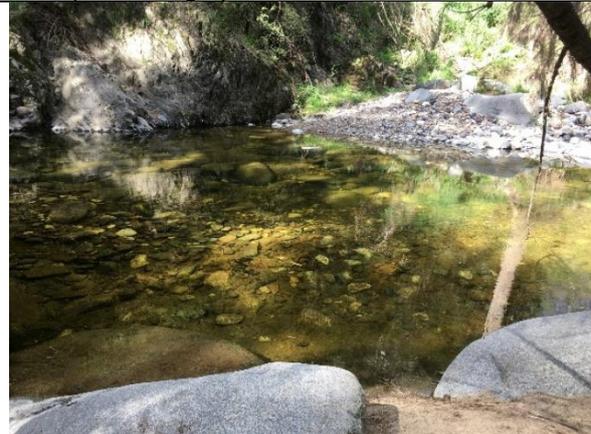
**Plate 2- Barbers Creek Downstream**

Plate 2 shows the Barbers Creek Downstream site. There are less boulders in this section of creek and the bed and banks have a high concentration of finer sediment. The banks show evidence of recent erosion and colonizing species are currently returning. There are some weed grasses occurring in the finer sediments.

a) Looking downstream June 2023

c) Looking downstream October 2020

d) Looking upstream October 2020

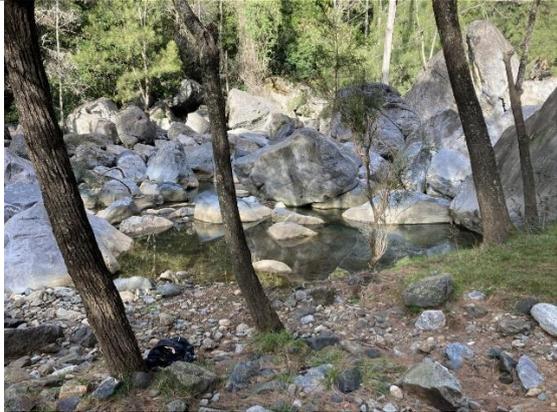
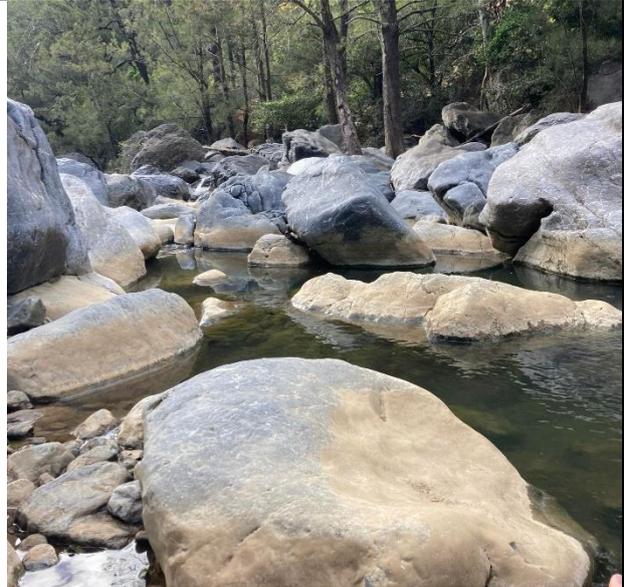
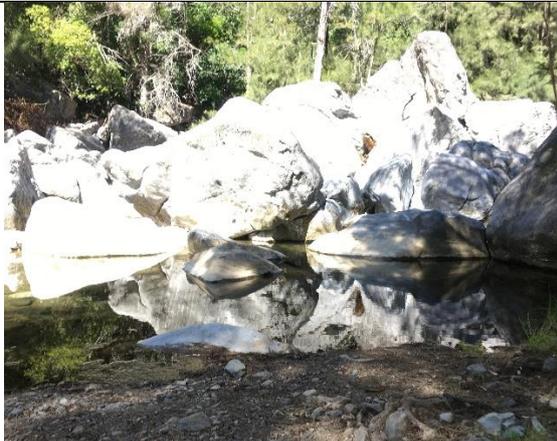
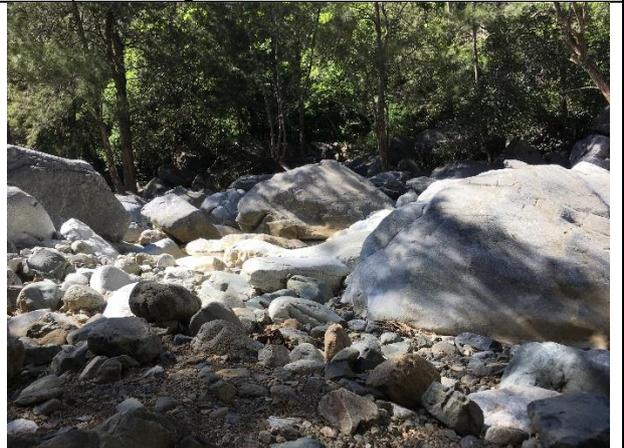
**Plate 3- Bungonia Creek Upstream June 2023**

Plate 3 shows the Bungonia Creek Upstream site. This site is characteristically filled with very large boulders. Some of these boulders have fallen down the tallus slopes rather than being relocated down the river bed. The banks are coarse grained but still representative of an erosive surface. The banks show evidence of recent erosion due to extreme water velocities. The boulders provide some energy dissipation which has allowed some finer sediment to be deposited on the upstream side.

a) North bank looking at creek June 2023

b) Looking downstream June 2023

c) Sample site October 2020

d) Looking away from site October 2020

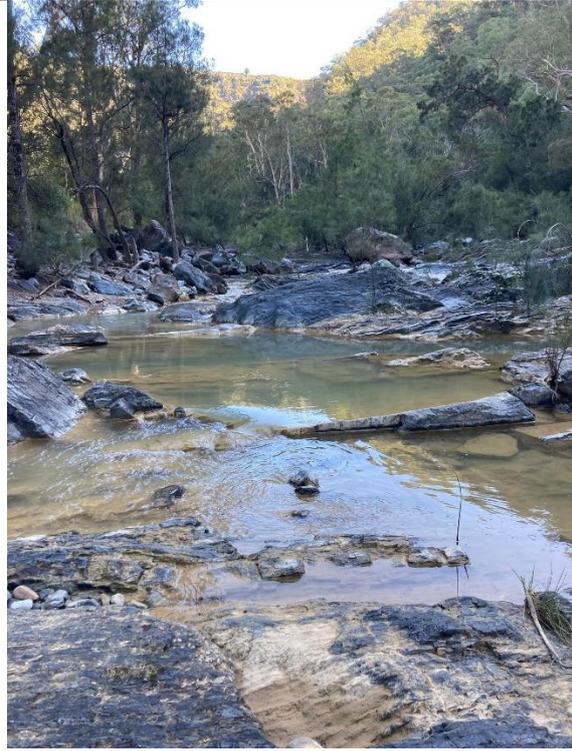
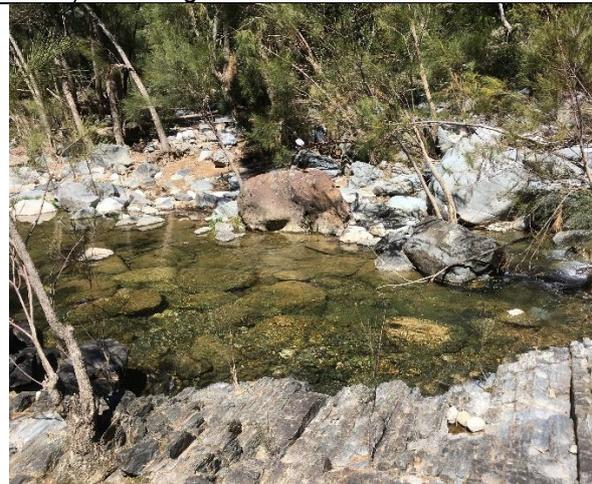
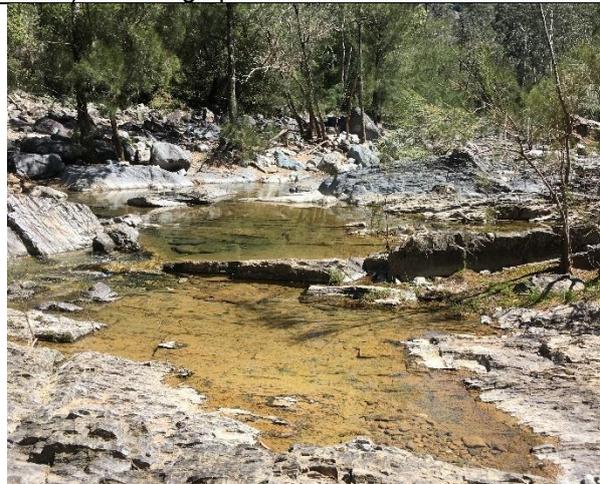
**Plate 4- Bungonia Creek Downstream**

As shown on Plate 3 and 4 of Appendix A, Bungonia Creek is strewn with boulders and pools. It runs through a steep sided narrow gorge for approximately 8.5 km upstream of the Shoalhaven River. The slope of the creek channel in the monitored section is approximately 4%. Bungonia Creek is also a fifth order stream at the junction of the Shoalhaven River.

b) Looking upstream June 2023

c) Looking across the sample site October 2020

d) Looking upstream October 2020

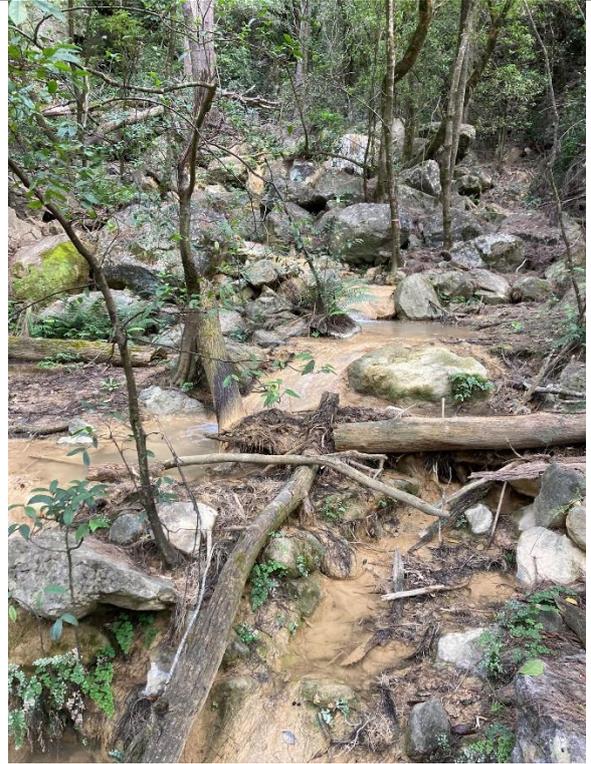
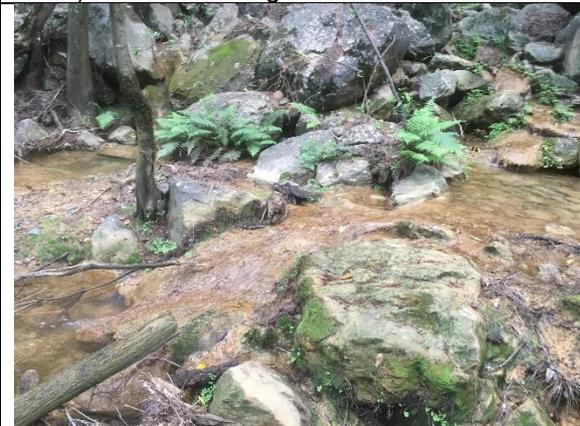
**Plate 5- Blowhole**

significantly different from the surface water of Bungonia Creek and has often been observed with an orange sediment present (Plate 5 in Appendix 1).

b) Looking up toward blowhole June 2023

c) Looking across flow path March 2020

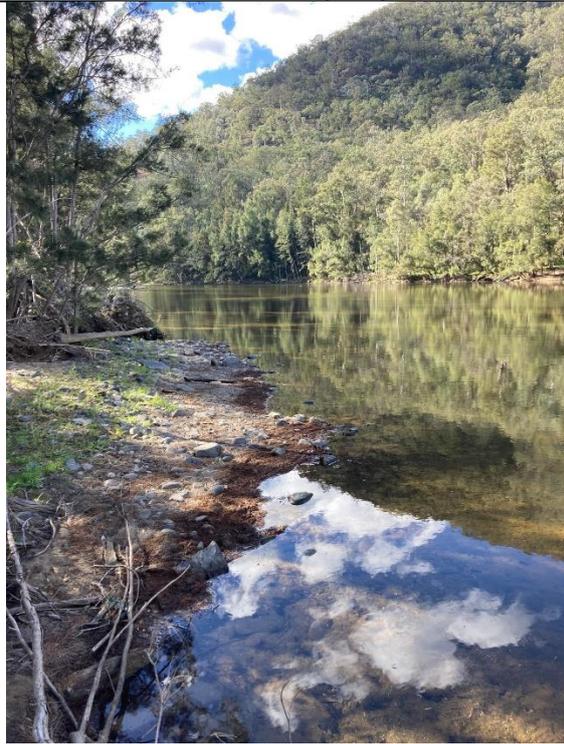
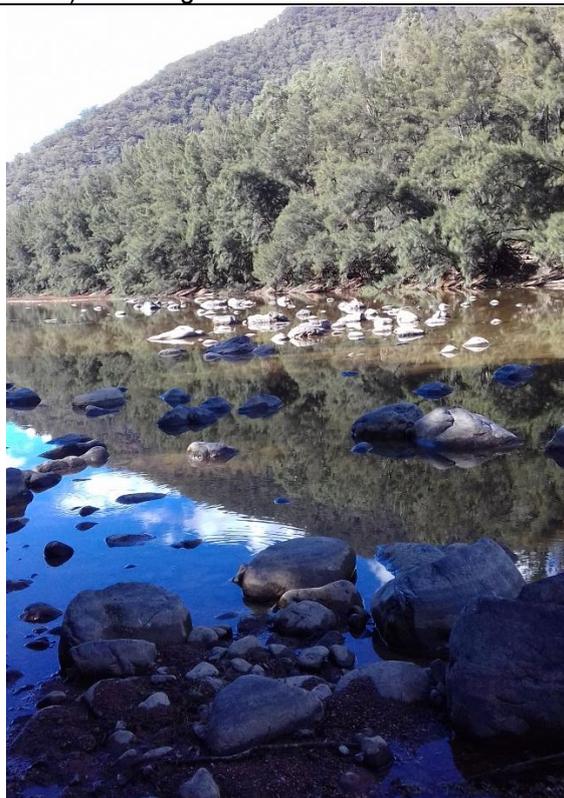
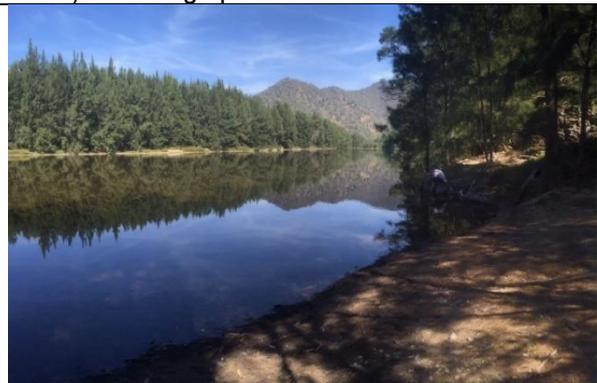
**Plate 7- Shoalhaven River (SR2)**

Further downstream at the SR2 site (Plate 7), the river enters a straight section where both banks have finer grained sand and silt deposits. Native vegetation cover extends over the bank to the river bed in many places and is considered stable. There has been little evidence of any change over the past three years.

a) Looking downstream June 2023

c) Looking downstream May 2019

d) Looking upstream March 2020

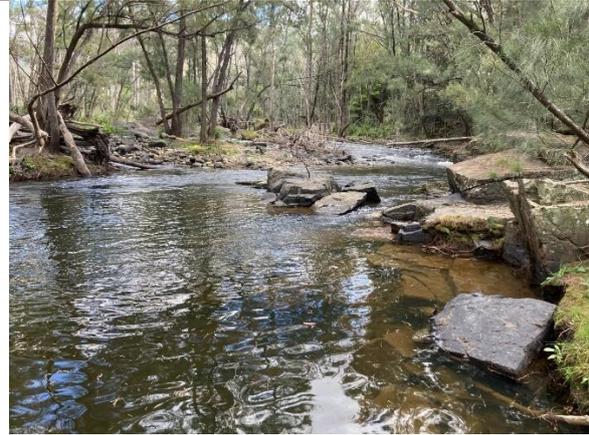
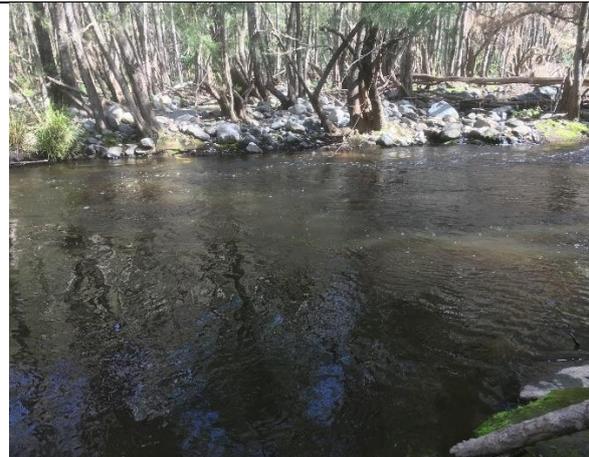
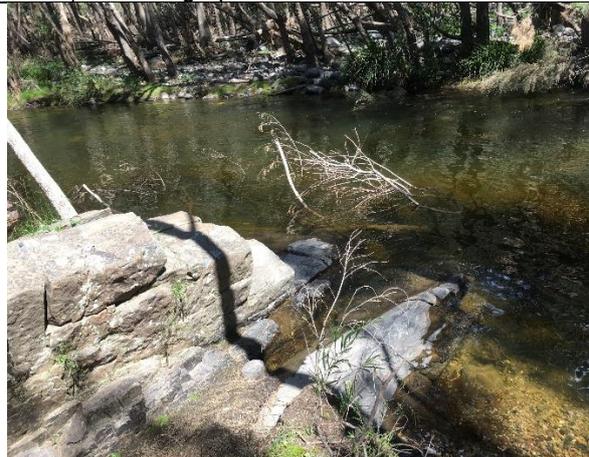
**Plate 8- Shoalhaven River Downstream (SR3)**

a) Looking downstream June 2023

c) Looking downstream March 2020

d) Looking upstream October 2020
