Prepared for:
Boral Resources (Metro) Pty Ltd
July 2016

Boral Peppertree Quarry

Annual Environmental Management Report (Jan 2015 - Dec 2015)

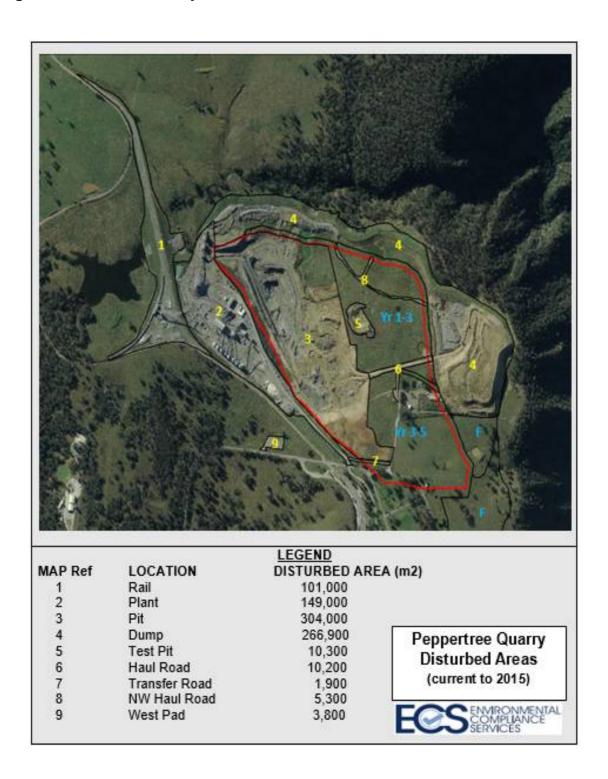
Figure 2: Disturbed Quarry Areas

Quarry Areas	Disturbed (ha)	Rehabilitated (ha)
Infrastructure area – Primary, STQ and TLO	25.0	No Rehabilitation Activity
Quarry extraction area	30.4	No Rehabilitation Activity
Active overburden emplacement	26.7	No Rehabilitation Activity
Test pit / west pad	1.7	No Rehabilitation Activity
Overburden emplacement / Noise bund (revegetated)	No Disturbance	12.1
Dam and creek rehabilitation area	No Disturbance	10.3
Total area Disturbed / Rehabilitated	83.8	22.4

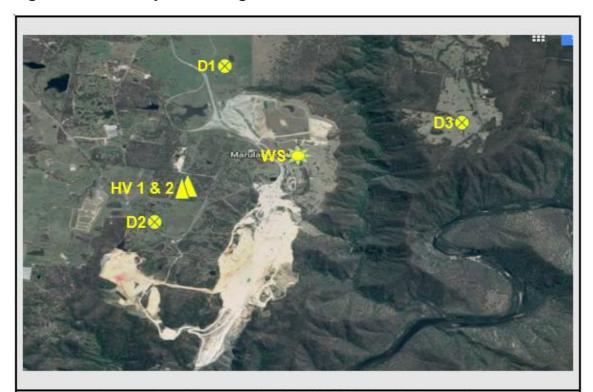
Figure 3: Air Quality Monitoring Locations

Peppertree Quarry - Air Quality Monitoring Locations

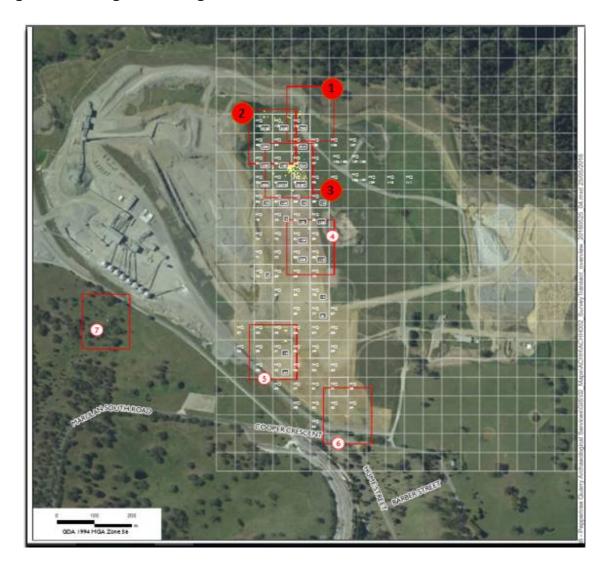
Figure 4: Aboriginal Heritage Areas

During 2015, artifact recovery operations were concentrated in Areas 1, 2 and 3 (refer to **Figure 4**).

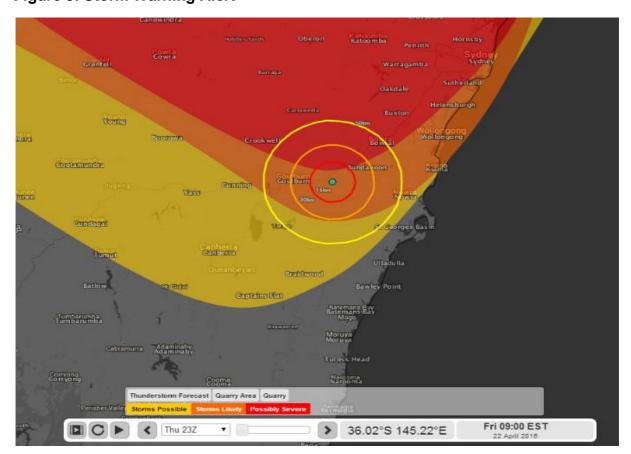
Figure 5: Storm Warning Alert

Example of the dashboard outputs are presented in **Figure 5** and **Figure 6**. **Figure 5** shows a high level storm approaching the Quarry in real time, while **Figure 6** shows predicted weather in coming days and the potential level of impact on operations.

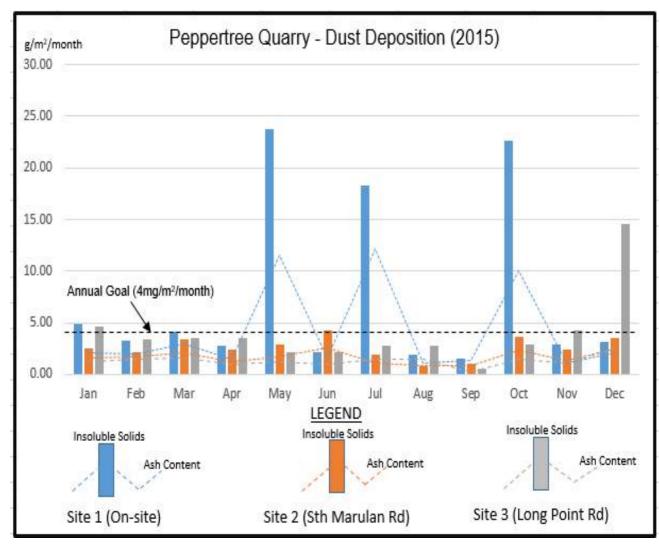
Figure 7: Dust Deposition Monthly Trends

Table 6 details the monthly results and annual averages of dust deposition from the three gauges. The results from the off-site locations (Sites D2 and D3) were within the Development Consent annual average criterion of 4 g/m²/month. While Site D2 was only marginally below the criterion, it should be noted that the annual average was significantly skewed by the December results. The annual average from the on-site dust deposition gauge (Site D1) was also significantly skewed by elevated results in May, July and October which based on ash content were unlikely to be representative of quarry dust.

An investigation to into each of the abnormally elevated monthly dust deposition rates could not identify any quarry related concerns during the respective periods and it is considered likely that external factors may have influenced the reported dust deposition results.

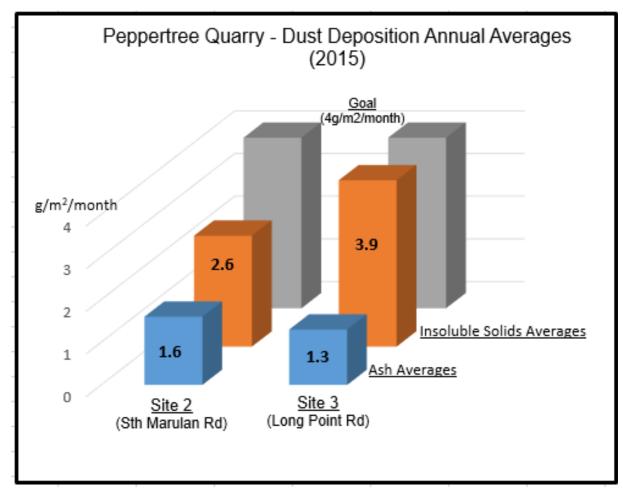
Figure 8: Off-Site Dust Deposition – Annual Averages

Figure 8 shows that the dust deposition annual averages at the off-site monitoring locations Sites D2 and D3, were in compliance with Development Consent criterion of 4 g/m²/month during the 2015 AEMR period. The relatively high percentage of ash in comparison to insoluble solids is an indication that some external sources were also contributing to the results.

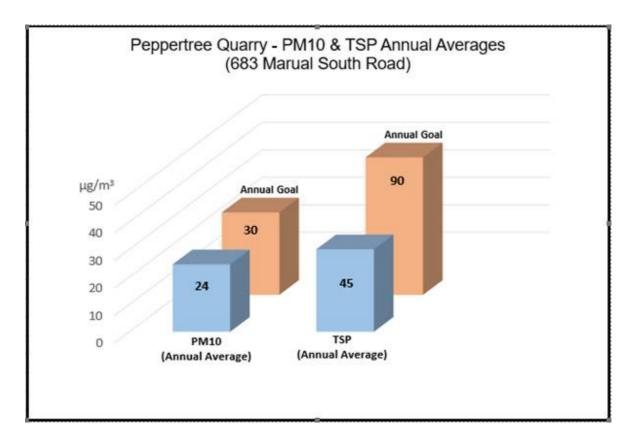
Figure 9: PM₁₀ & TSP Annual Averages

Each of the above exceedances were investigated and no quarry operational issues were able to be identified as the cause of the elevated results. However, the investigation noted that a change in practice had occurred in November 2015 where the transport of lime by trucks to the Aglime facility had commenced. Anecdotal evidence from the trucking company involved in transporting the lime indicated that vehicles may not have been adequately covered. Subsequently, all drivers were made aware of the need to cover loads and no further PM₁₀ exceedances were reported.

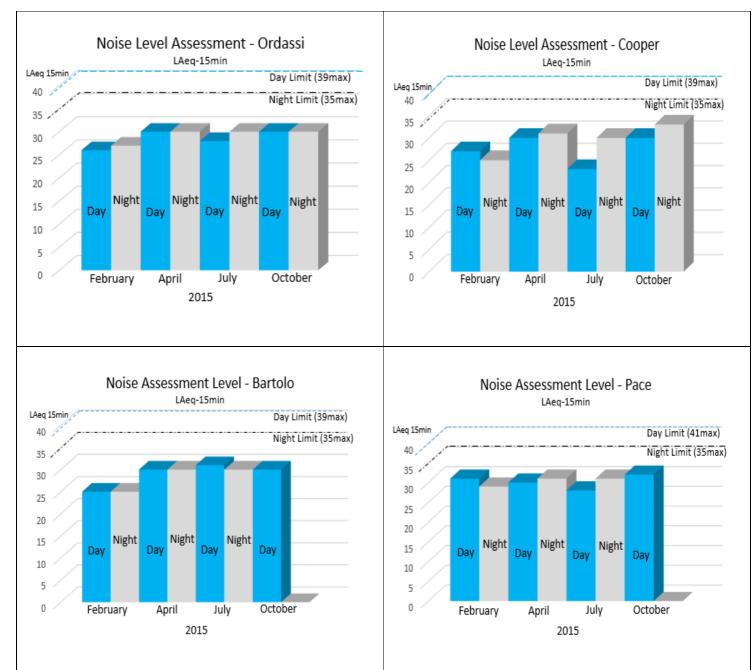
Figure 10: Off-Site Noise Level Trends (LAeq 15)

Table 7 provides a summary of the maximum day and night time noise assessment measurements against the respective Development Consent compliance criteria for measured L_{Aeq} (15minutes) noise levels at all four receiver locations. The assessment results found that the Quarry L_{Aeq} (15minutes) noise levels were in compliance with the averaged levels being considerably lower than the respective prescribed limits (refer to **Figure 10**).

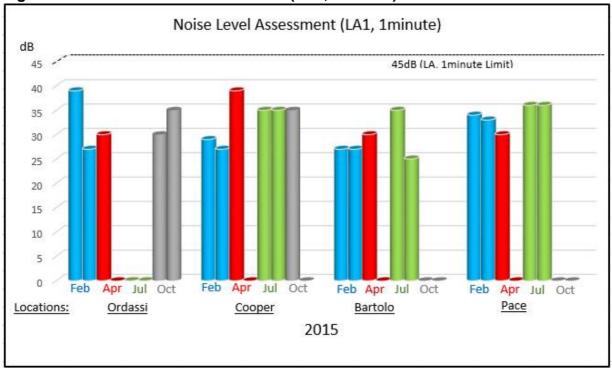
Table 8 provides a summary of the maximum night time noise assessment measurements against the respective Development Consent compliance criteria for measured La1, 1 minute noise levels at all receiver locations. The assessment results found that the Quarry La1, 1 minute noise levels were in compliance with the averaged levels being considerably lower than the respective prescribed limits (refer to **Figure 11**).

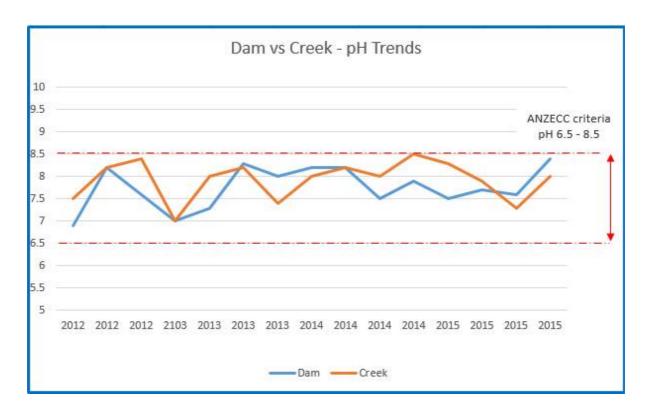
Figure 14: pH Trends – Quarry Dam Vs Creek

Surface water quality monitoring is undertaken quarterly from Tangarang Creek, Dam 1, upstream culvert, and overflow from sediment ponds T, U, V1, V, W, W1, W2, X and K. The Quarry's main Dam provides environmental flows into the ephemeral Tangarang Creek and as such water quality is largely representative of the discharges with some minor natural variations from the wider catchment influences.

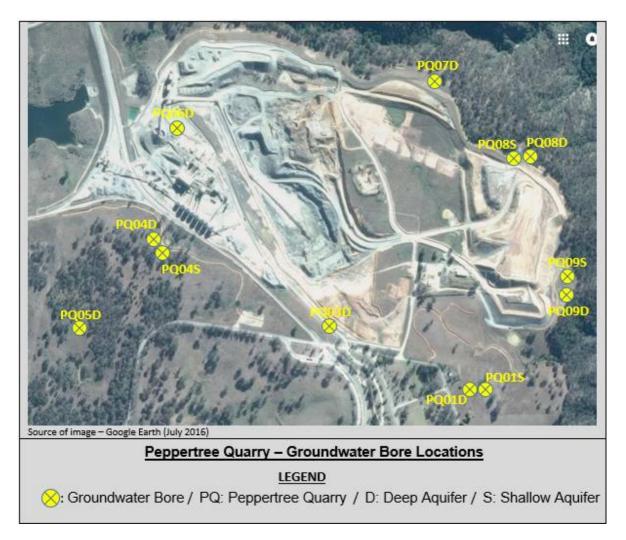
Figure 18: Groundwater Monitoring Locations

Between August and October 2015, a total of 12 groundwater bores were installed which included seven deep monitoring bores and five shallow monitoring bores ranging between 15m to 100m (refer to **Figure 18**). The groundwater bores will provide monitoring coverage in accordance with Development Consent Condition 30 (Schedule 3) requiring the development and implementation of a Groundwater Monitoring Program.

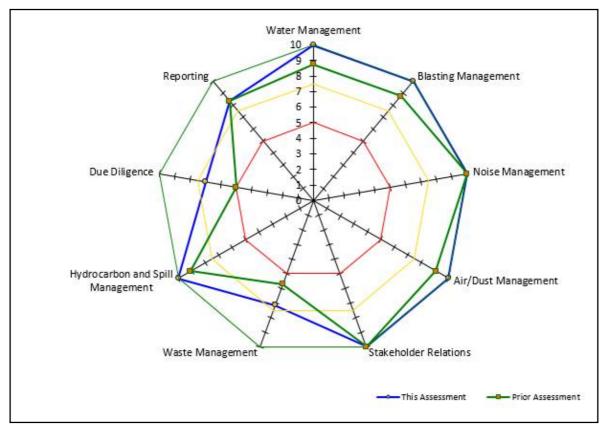
Figure 20: Site Environmental Assessment Scores

Figure 20 presents the SEAT scores for the respective AEMR reporting periods. The 2015 SEAT scores improved on the 2014 assessment on most of the environmental elements. However, there remain elements such as Reporting, Diligence and Waste Management on which improvements are being prioritised for action during the 2016 AEMR (refer to **Table 13**).
