Boral Dunmore Hard Rock Quarry Annual Review

1 July 2024 – 30 June 2025

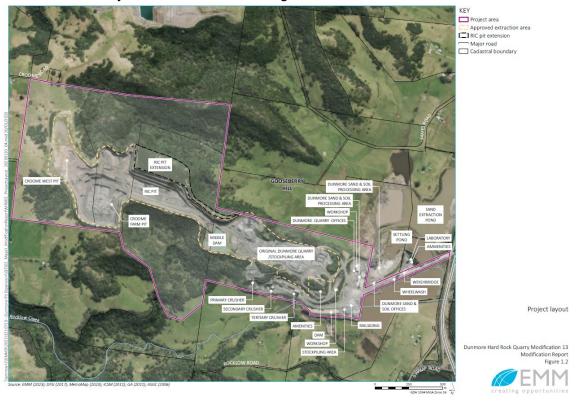
Figure 1 Dunmore Site Layout

During the previous reporting period extraction has occurred in the area known as the Croome West Pit. Approval of the most recent modification, MOD 13, was granted in June 2024. Extraction of the approved area under MOD13, known as the RIC, commenced in the current reporting period as of March 2025. Notification of commencement was submitted to DPHI. The site layout is shown below in Figure 1.

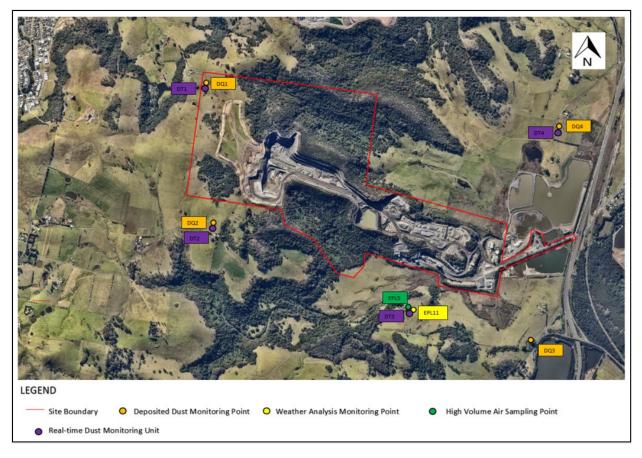
Figure 2 Air Quality Monitoring Locations

The location of air quality monitoring equipment is shown below in Figure 2.

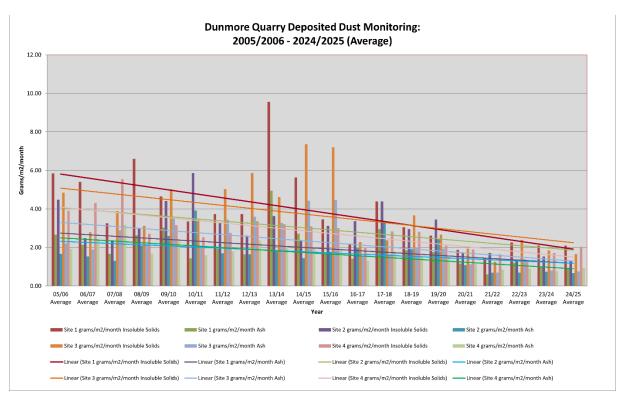
Figure 8 Historical Dust Monitoring Data

The DQ site has been collecting deposited dust data since 2002. A graph of long-term trends can be found in Figure 8 below and shows that deposited dust has typically decreased over time.

A general trend that has been observed is that measured deposited dust is typically higher in dry summer months than winter months, which is to be expected. This trend is also confirmed with the PM_{10} measurements and is generally reflective of regional conditions as a whole.

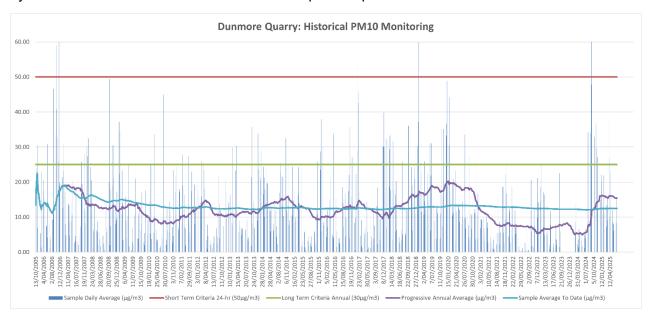
Figure 9 Historical PM₁₀ Monitoring Data

Figure 9 shows a 90 day average in black, which illustrates a seasonal fluctuation of measured PM₁₀ values. A trend can be observed that PM₁₀ values are typically higher during summer dry periods and are lower during the winter periods.

This fluctuation is mirrored in the Office of Environment and Heritage's (OEH) Albion Park PM₁₀ measurements available on the OEH website (https://www.dpie.nsw.gov.au/air-quality-data-services/data-download-facility)

These trends indicate the measured PM₁₀ and deposited dust values are typically influenced by ambient local conditions rather than development operations at DQ.

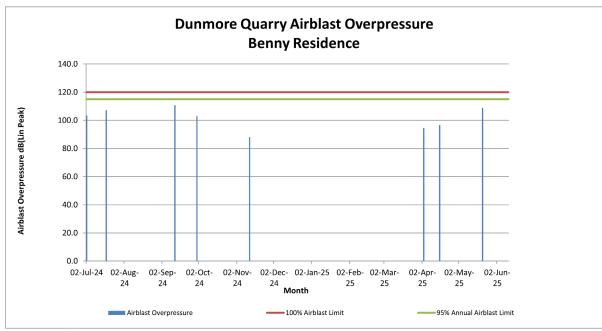
Figure 11 FY25 Overpressure Data

Figure 11 and Figure 12 details a visual representation of the blast monitoring in FY25. A number of blasts did not trigger and therefore aren't represented in the figures below. The data table associated with these can be found in Appendix D.

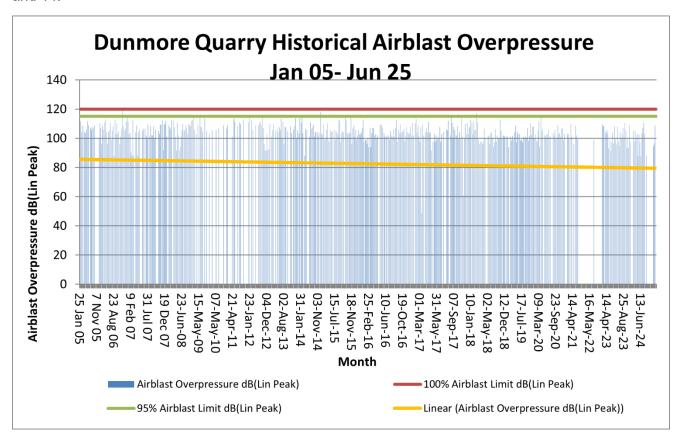
Figure 13 Historical Overpressure Data

A visual representation of historical blast monitoring data can be seen below in Figures 13 and 14.

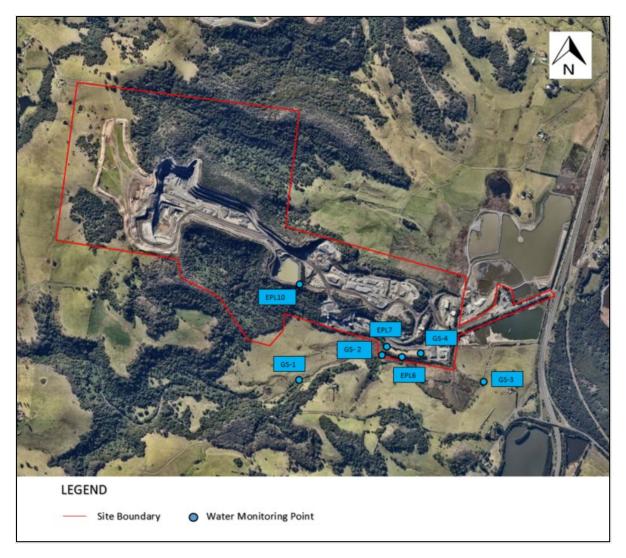
Figure 22 Surface water monitoring points

- EPL6 which is a controlled discharge from the Lower Dam using a biofiltration swale to treat water prior to entering Rocklow Creek.
- EPL7 which is the spillway of the Lower Dam which only discharges during high rainfall events.
- EPL10 which is the upper emergency spillway of Middle Dam. Water spilling from the main spillway of Middle Dam flows into the Lower Dam.

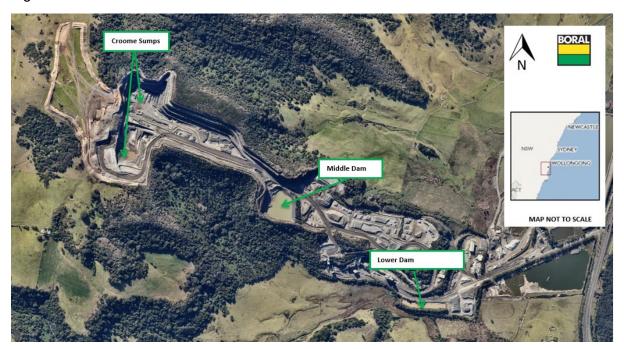
Figure 27 Water Storage Locations

All process water was sourced by either the Lower Dam, Middle Dam or Croome Sumps, which are offline from Rocklow Creek as per water management upgrades undertaken in 2008 under MOD 4. The Location of water storage infrastructure is shown below in Figure 27.

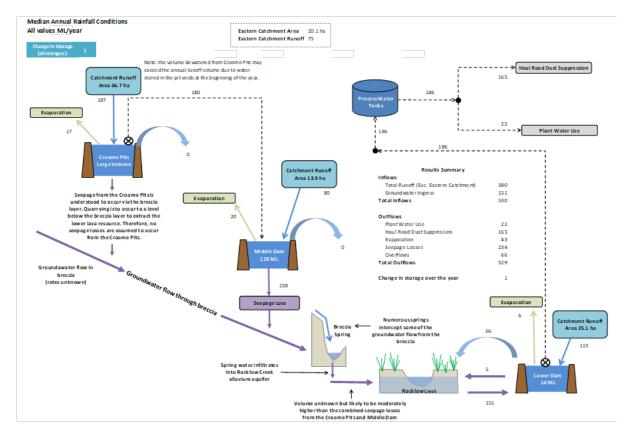
Figure 28 Existing water management system: typical wet year water balance

The updated WMP outlines a range of water balance scenarios based on different climate conditions. The median rainfall scenario (1063mm rainfall) best reflects rainfall for the FY25 period (annual rainfall was 944mm) as shown in Figure 28. As a result, the process water use was modelled to be 114.7ML for the reporting period with a change of storage of +1ML over the year within the three dam storages, indicating that water take was well within licenced volumes.

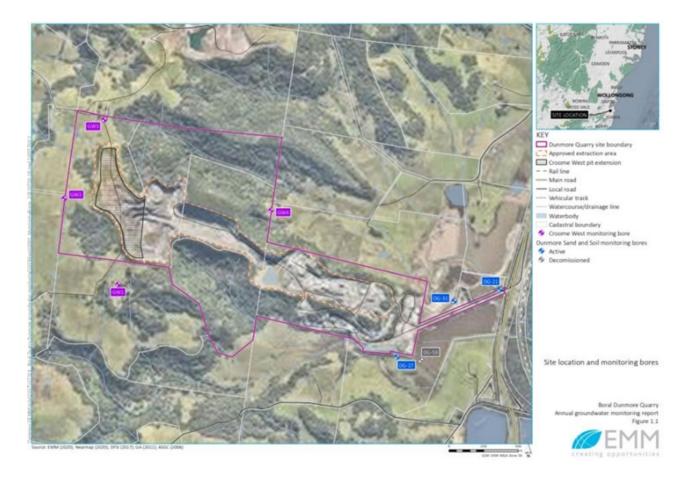
Figure 29 Groundwater Monitoring Bores

An annual groundwater monitoring report has been prepared by EMM Consulting Pty Ltd, in accordance with condition 44C. This report is included in full within Appendix E. The monitoring program uses the established down gradient bores at Dunmore Sand and Soil (DG-31, DG-59 and BH-F) and four established up gradient bores at Dunmore Quarry (GW-1, GW-2 and GW-3). Location of Groundwater monitoring bores are shown below in Figure 29.

The monitoring bores are located up hydraulic gradient from current quarrying activities and are therefore considered representative of baseline conditions (both water levels and quality). Groundwater monitoring for the up-gradient bores includes six-hourly groundwater level measurements and typically consist of six-monthly groundwater sampling events. Testing was conducted in July 2025.

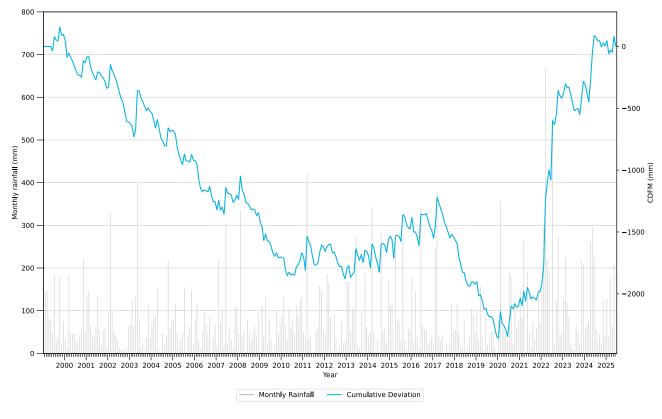
Figure 2.1 Cumulative deviation from long-term monthly mean rainfall

It is noted that above average rainfalls were recorded for July and August 2025 (175.8 and 267.4 mm respectively) and over 156 mm of rainfall was recorded seven days prior to the monitoring event.

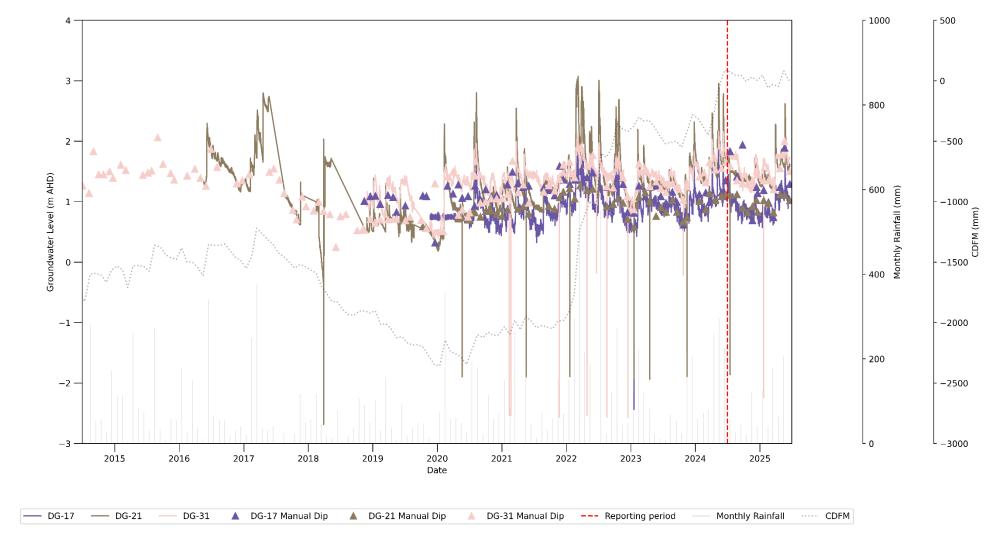
Figure 4.1 Groundwater levels in the alluvium

Groundwater level trends in the alluvium (DG-31S and DG-21) are comparable to the previous monitoring period. These shallow alluvial monitoring bores show a direct and immediate response to rainfall events with DG-21 and DG-31 showing the most pronounced responses. The highest groundwater level increase was observed at DG- 31S (approximately 1.3 m). During the reporting period, the water levels fluctuated corresponding to the prevailing rainfall conditions and were within historical observations. Manual dip data at DG-17 displays large variability across the period, a likely response of rainfall variability across the period (drier periods, followed by intense rain events). GW1 recorded a water level decline between July 2024 and March 2025 (about 13 m) corresponding to a period of below average monthly rainfall. The groundwater level recorded a low of 100.2 mAHD in late March 2025 which was still within the SSTVs. Groundwater levels recovered (approximately 13 m) during the wetter conditions from April 2025 onwards.

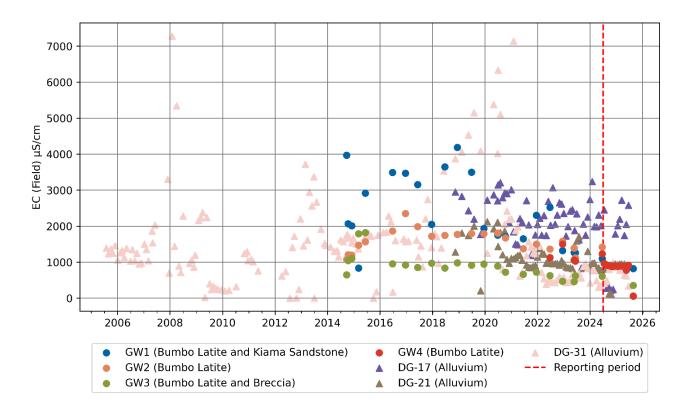
Figure 5.1 EC timeseries for all monitoring bores

EC in the alluvium shows a large range and high variability during the 2024/2025 monitoring period. The high salinity at these bores can be attributed to their proximity to the tidally influenced Rocklow creek. At DG-17 low EC (223 to 283 μ S/cm) was recorded between August to November 2024. Similarly, low EC (112 to 119 μ S/cm) at DG-21 was recorded between September and October 2024. These decreases in EC may be attributed discharges and seepages from onsite storage dams through the breccia from the significantly above average rainfall period between April to June 2024. The pH in the alluvium was slightly acidic during the monitoring period, in line with historical trends. There was a spike of higher pH (more alkaline) across all three alluvial bores in March 2025, however this is more likely a result water quality metre inaccuracy. The March 2025 pH values at DG-17 and DG-21 were the highest on historical records.

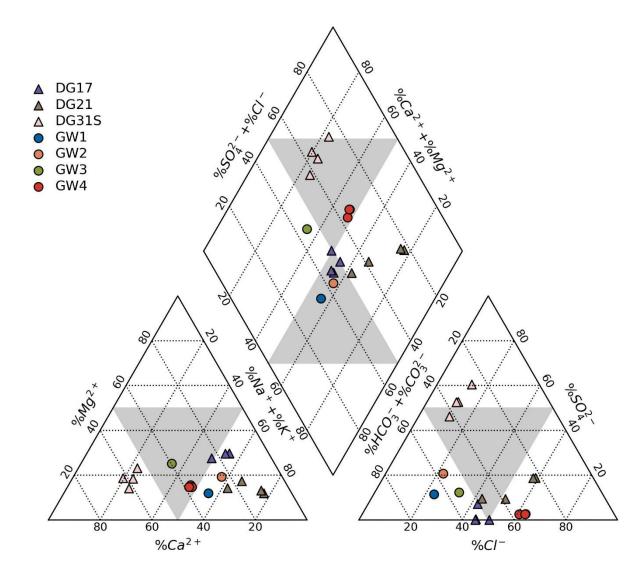
Figure 5.3 Piper plot for all monitoring bores (2024/2025 reporting period)

Major ion concentrations measured at the alluvial monitoring sites show some changes compared to the previous year. DG-17 remains sodium bicabonate dominant. DG-21 shows a shift from a sodium bicarbonate type towards a more sodium chloride type. DG-31 show a shift from a calcium bicarbonate type towards a more calcium sulfate water type.

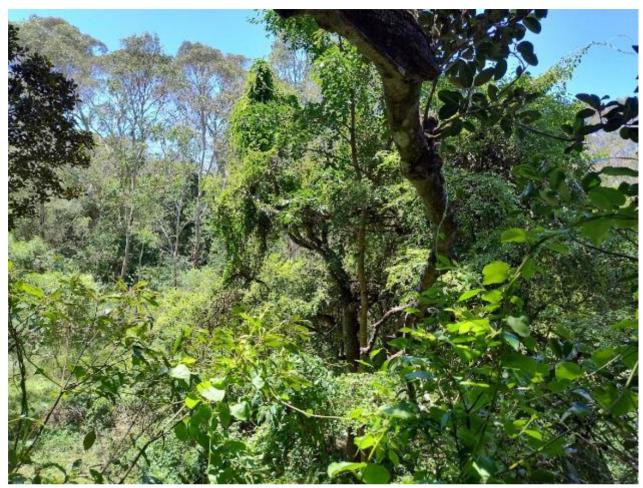
Madeira Vine ascending 5m into the Alphitonia, 23rd December 2024

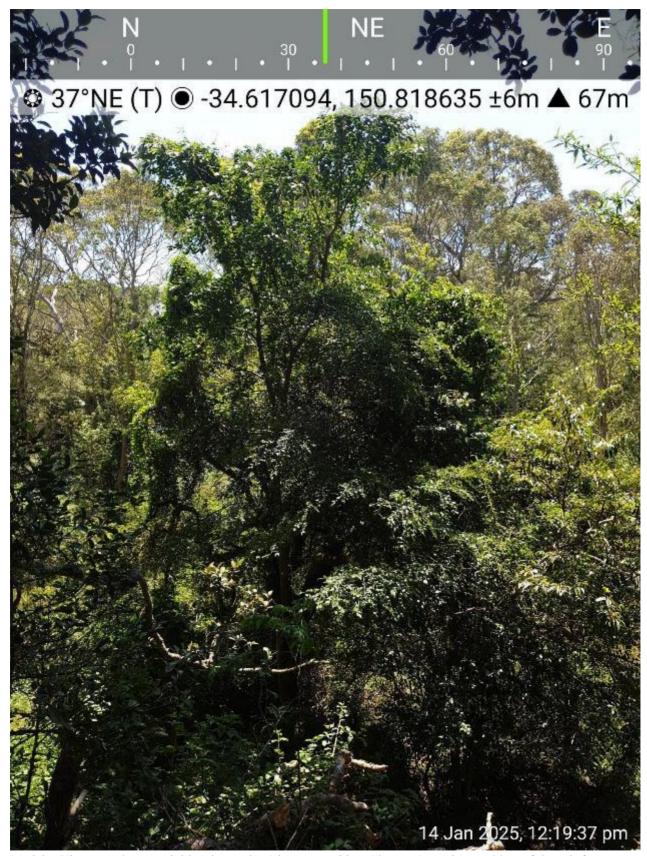
Madeira Vine covering an Alphitonia excelsa (also covered in a Ficus sp.) on the outskirts of the rainforest canopy along Rocklow Creek. 14th January 2025

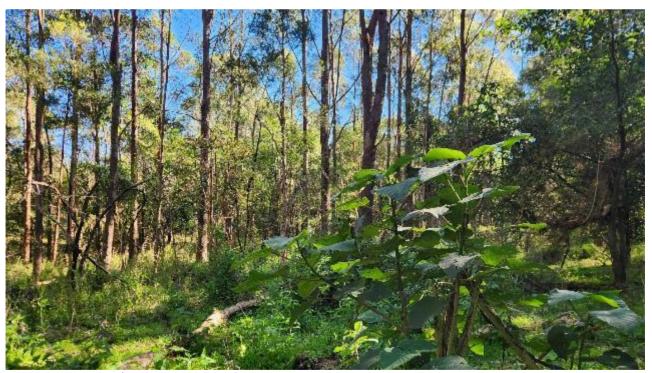
Evidence of rutting/damage caused by deer and regeneration of RF species in old revegetation area

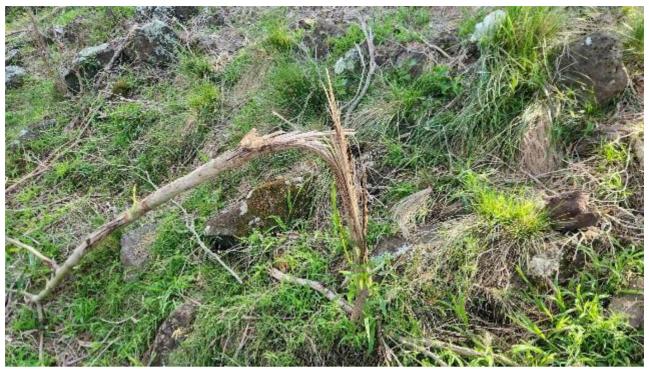
Old deer damage to a regenerating Hibiscus heterophyllus
