# Annual Compliance Report

03 February 2023 to 02 February 2024 EPBC 2016/7797  
Ormeau Quarry Expansion, 12 km north-west of Oxenford,  
Queensland  
Prepared for Boral Resources (QLD) Pty Ltd

Document: EPBC Annual Compliance Report (Year 3), prepared by Saunders Havill Group for Boral Resources Pty Limited, dated 1<sup>st</sup> May 2024.

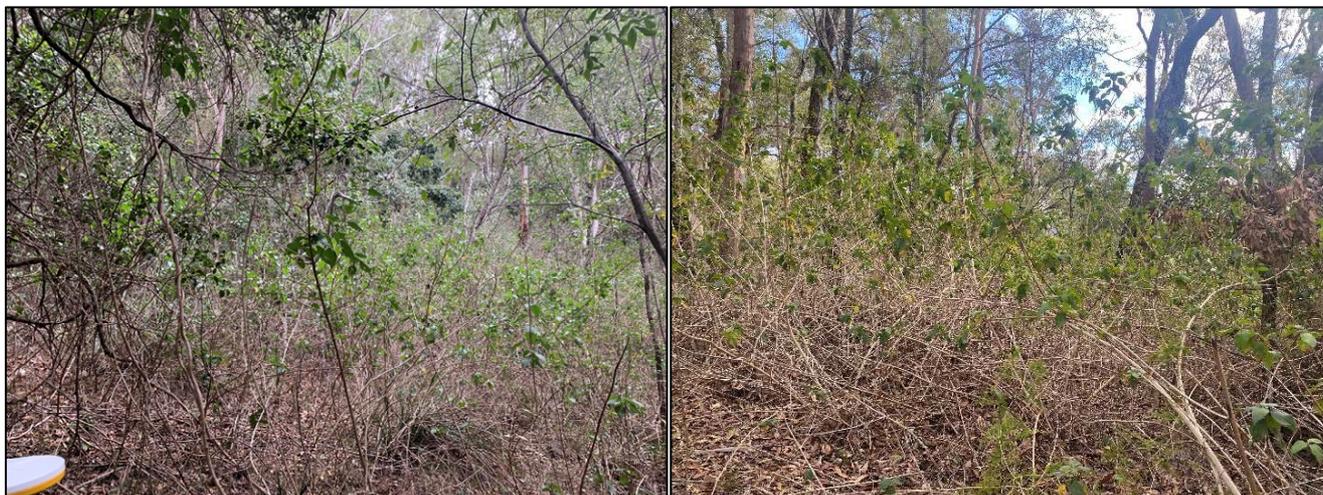
**Photo set 1:** Dense *Lantana camara* patches

SHG ecologists spatially recorded areas within the offset area containing WONS, specifically targeting *Lantana camara* (Lantana). Refer to **Plan 4** for the Year 3 weed mapping results. As shown on the plan, WONS are present in varying density levels across the site. (refer to **Photo set 1**).

Bushcare services continued treating WONS across the site during the current compliance period in the southern portion of the site that could be safely accessed. Accessibility issues continued into Year 3, due to heavy rainfall impacting the construction of the culvert on three separate occasions (refer to **Section 4.1** for further details). Treatment methods completed in areas that could be safely accessed included chemical treatment (cut and paint) and manual removal. Manual removal was the preferred method of removal due to weather conditions. Weed treatment areas are demonstrated on **Plan 5**.

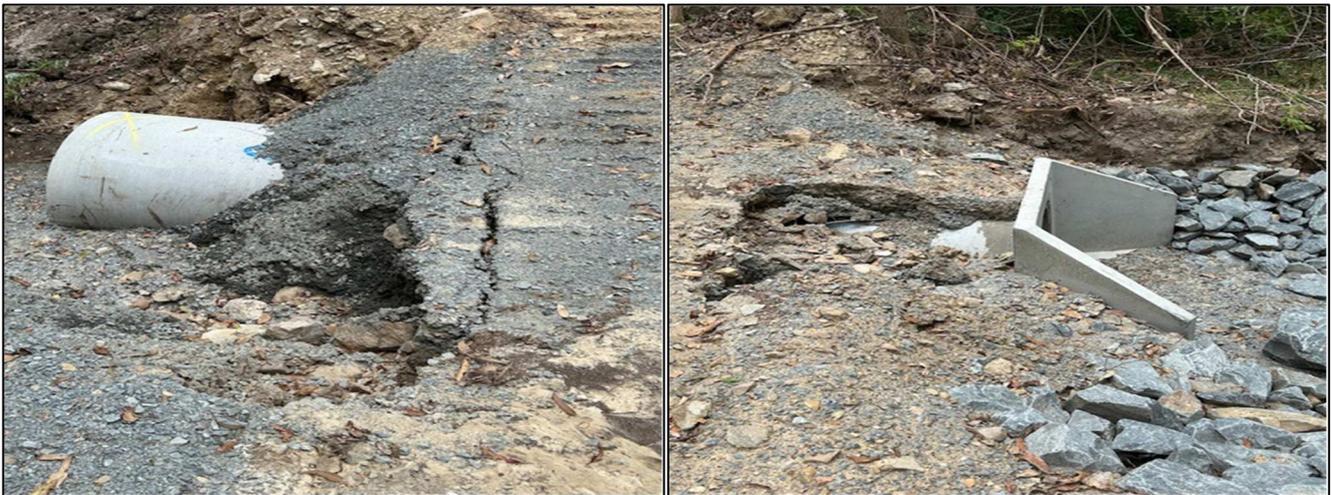
**Photo set 2: Washout at Headwall, photos dated 19 December 2023.**

On the 19 December 2023, after receiving heavy rainfall over the weekend, the crossing was inspected and the high rainfall resulted in the rainwater going down the drain, and a washout near the headwall occurred (refer to **Photo set 2**).

Boral have construction contractors preparing to commence the rebuild of this crossing in the coming months, for completion, to avoid any further issues with weather damage. Following construction, the design of the crossing will hold against such weather events, providing functional access to expedite the planned management actions safely and effectively.

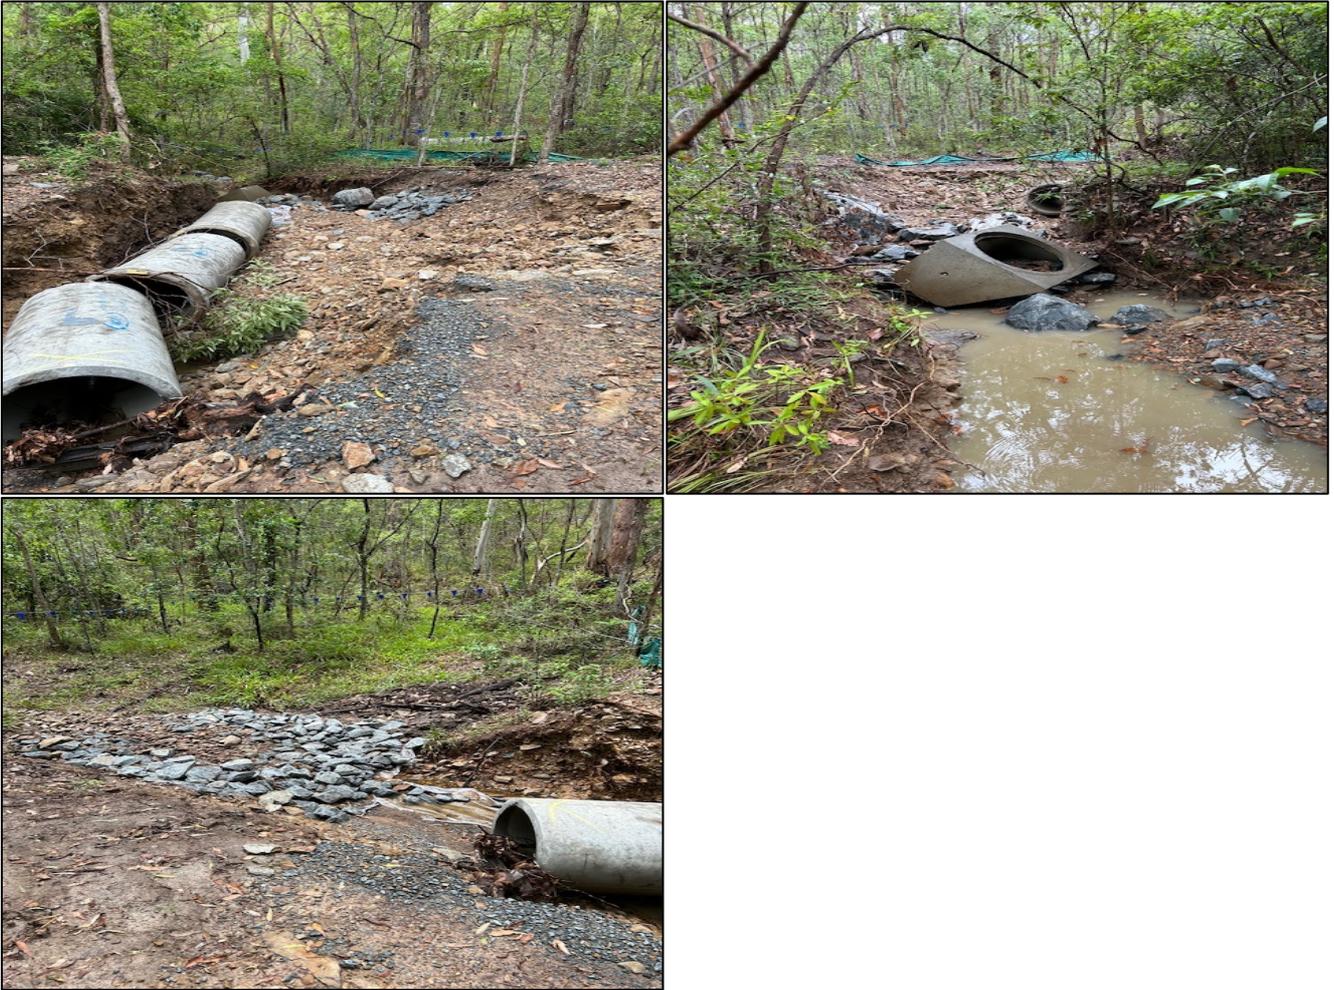
**Photo set 3: Damages to crossing, dated 8 January 2024.**

On the 8 January 2024, the crossing was inspected again, following heavy rainfall over the Christmas period. The heavy rainfall results in the crossing being damaged again, requiring a complete re-build once the rainfall had ceased.

Although dated outside of the Year 3 reporting period, the crossing was inspected on the 18 February 2024 following significant rainfall received on the 16 February 2024. The crossing was damaged again, requiring reconstruction.

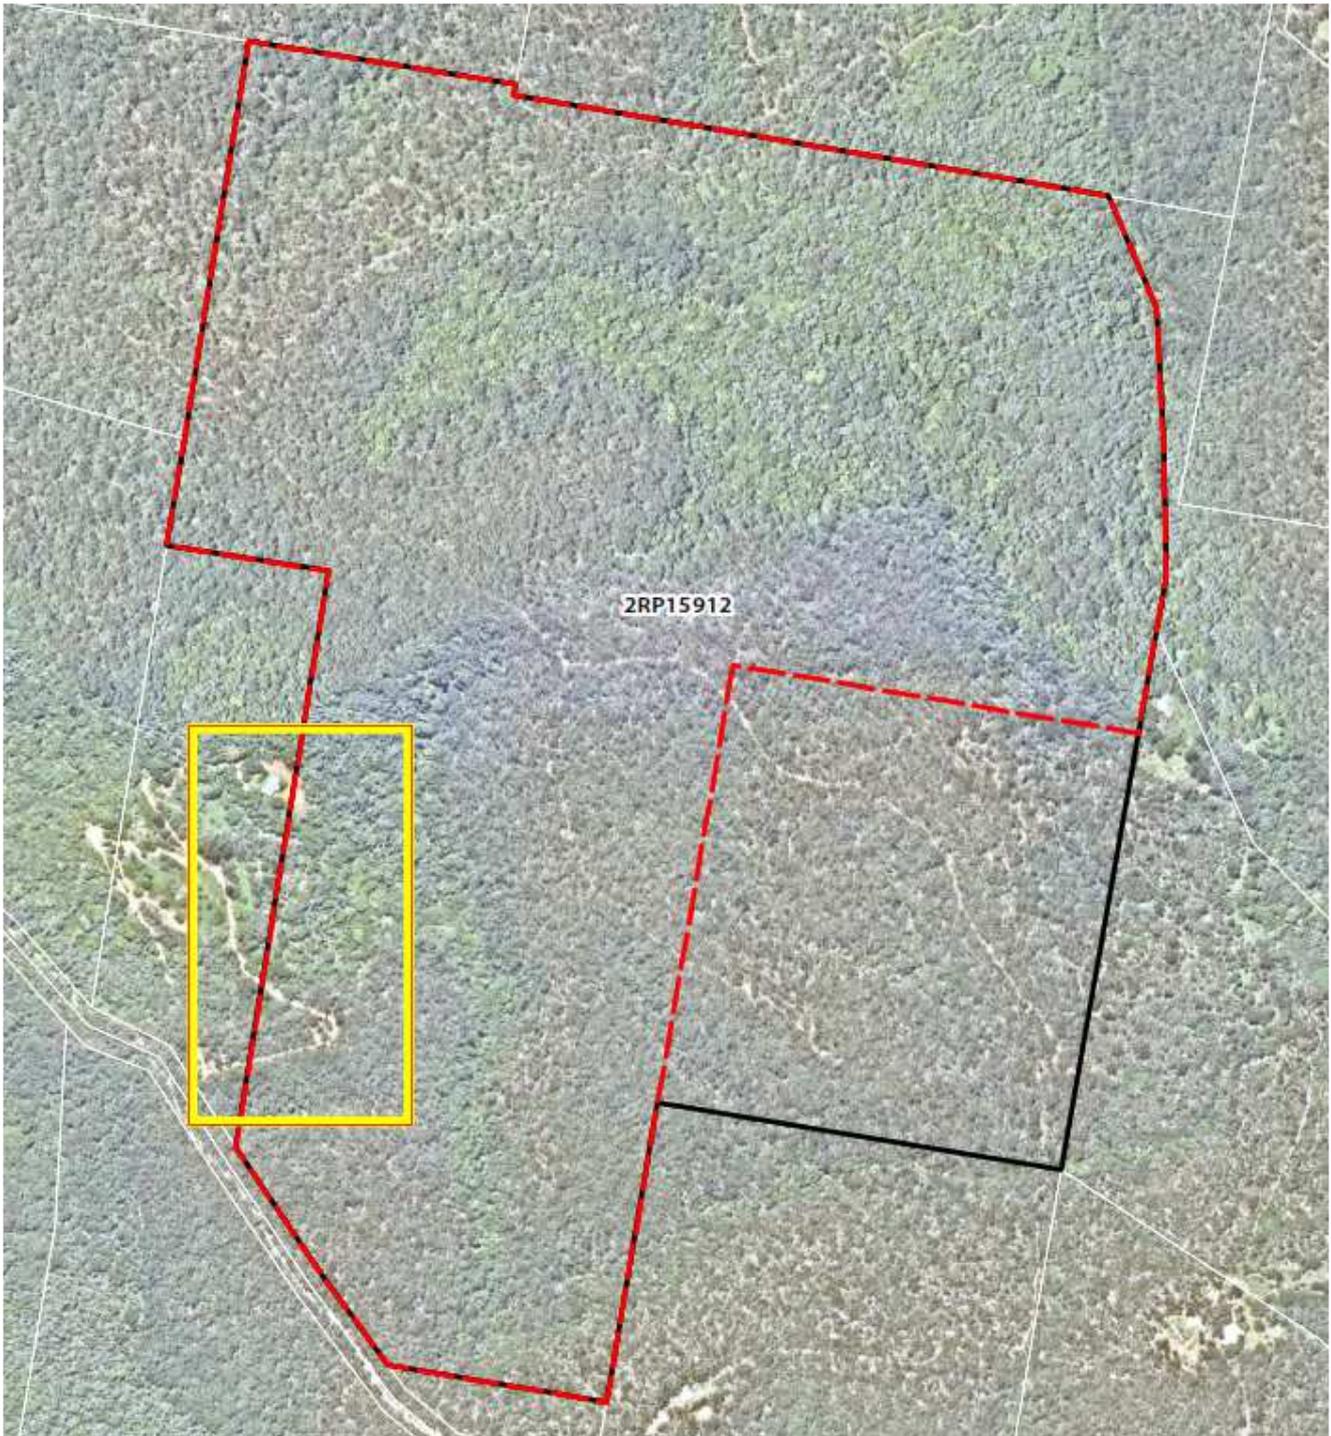
Under the EPBC Act approval, specifically condition 6, clearing within the offset area is not permitted. However, as the clearing was not undertaken by Boral and relates to historical clearing predating the securing of the offset area, it is considered a minor non-compliance under the EPBC Act approval. As the clearing is against the objectives of the OMP, actions were proposed to prevent further clearing of the area and integrate it back into the management regime of the offset area under the OMP and specific offset area management plans.

**Figure 3:** Location of accidental historical encroachment by neighbour, discovered during surveying of offsets site boundary.

No additional clearing or issues arising from this historical incident have occurred during the current reporting period. The management of these areas are occurring in accordance with the requirements detailed within the Koala Habitat Rehabilitation Management Plan and as specified within the chosen management methods for the encroached area. As such, the minor non-compliance is considered to have been sufficiently addressed and resolved during the Year 1 ACR reporting period.

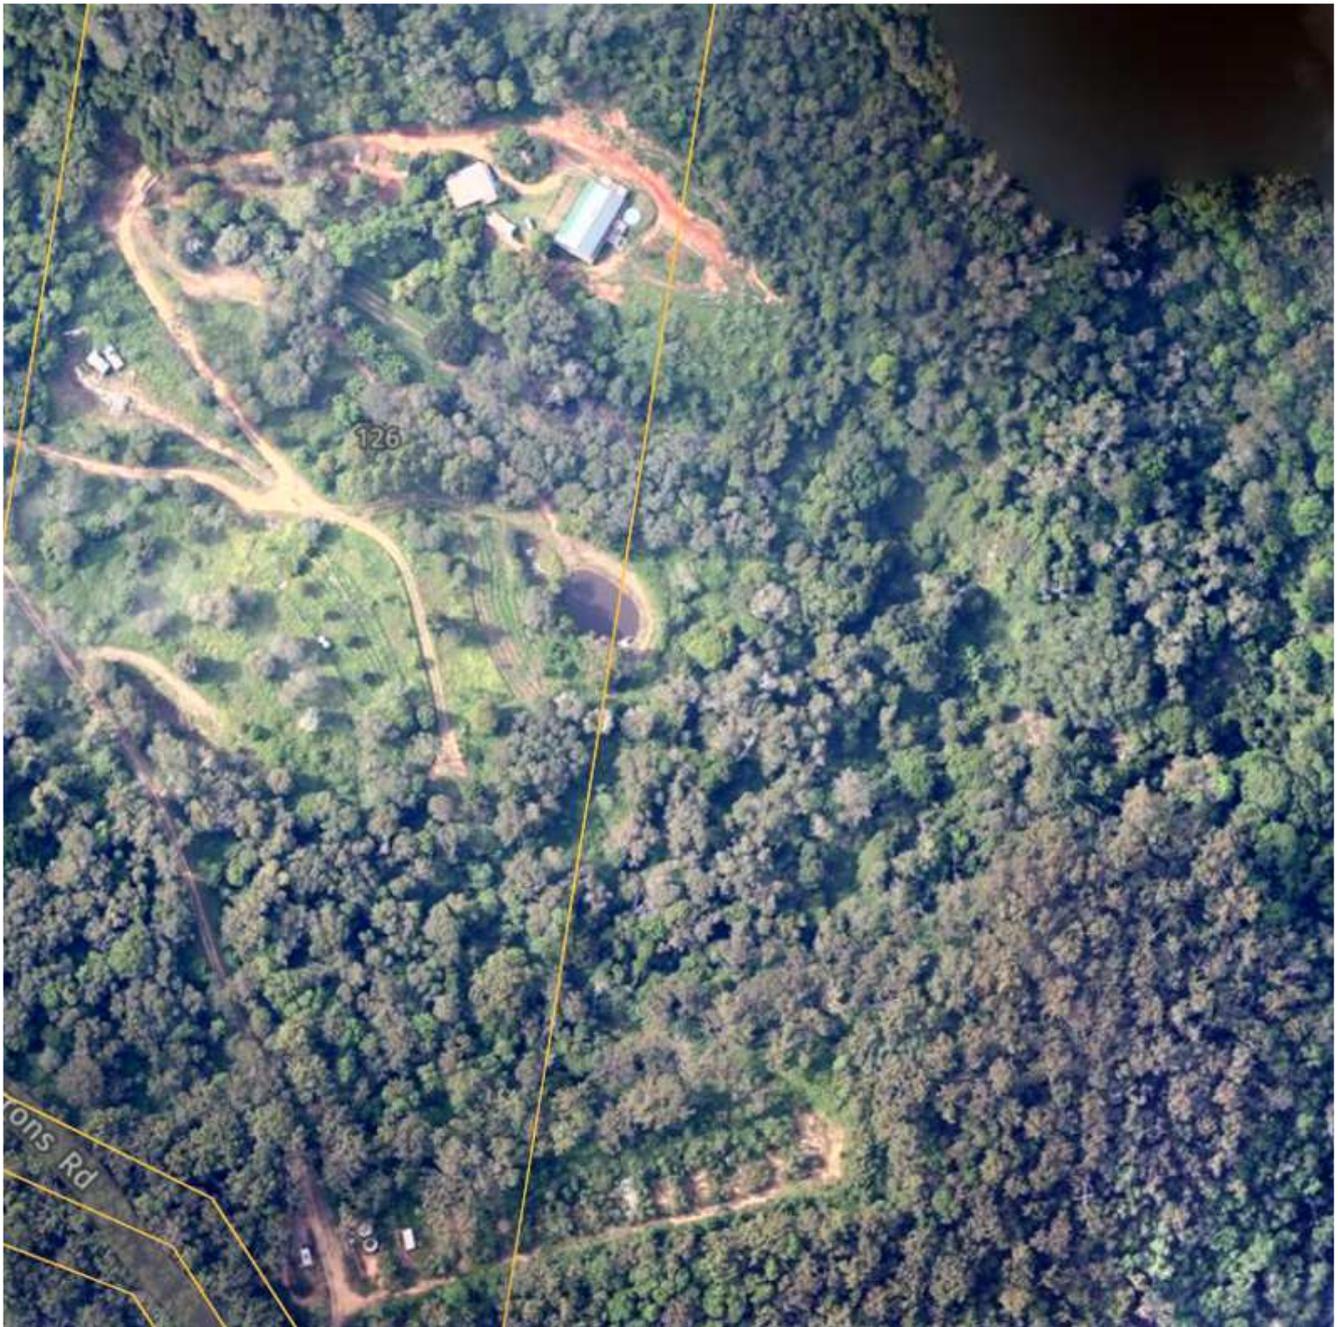
**Figure 4:** Aerial showing the western boundary of the offsets site and the prior encroachment into the site unknowingly by neighbouring landholders.

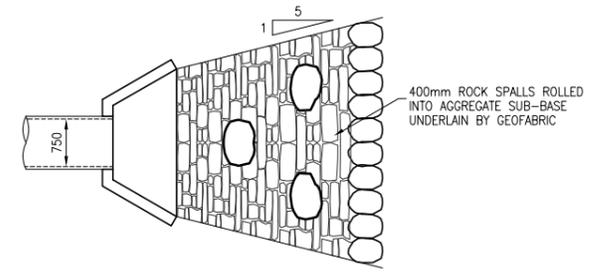
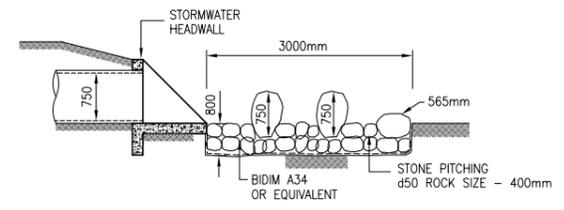
**STONE PITCHING DETAIL**  
NOT TO SCALE

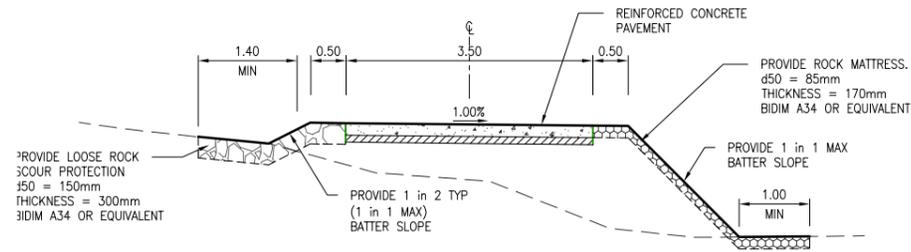
**TYPICAL CROSS SECTION**  
1:50 SCALE @ A1 SIZE

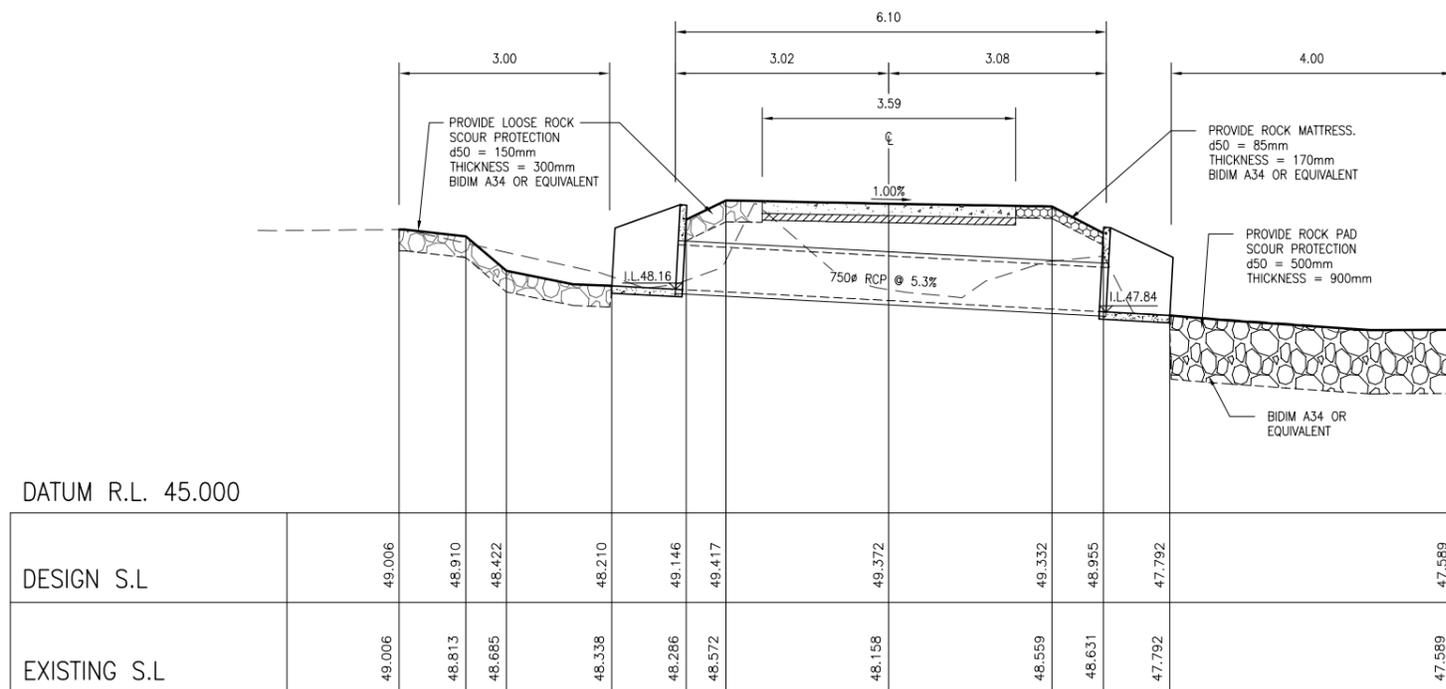
SECTION B  
1:50 SCALE @ A1 SIZE C01

B	19.10.2022	CULVERT SECTION REVISED	DRAWN B.J.M.										SHEET NUMBER 03 of 05		REVISION C	
A	13.06.2022	US & DS SCOUR PROTECTION AMENDED	CHECKED B.C.A.										DATE MAY 2022		FILE NAME Culvert_Lsec.dwg	
No.	DATE	REVISIONS	FILE NAME

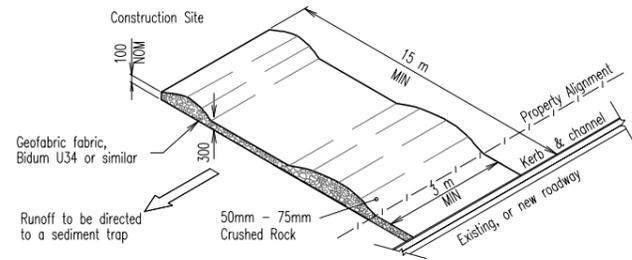
CONSTRUCTION ENTRY/EXIT SEDIMENT TRAP
