Marulan South Limestone Mine | SSD 7009

REHABILITATION STRATEGY

Prepared for Boral Cement Limited | 21st November 2023

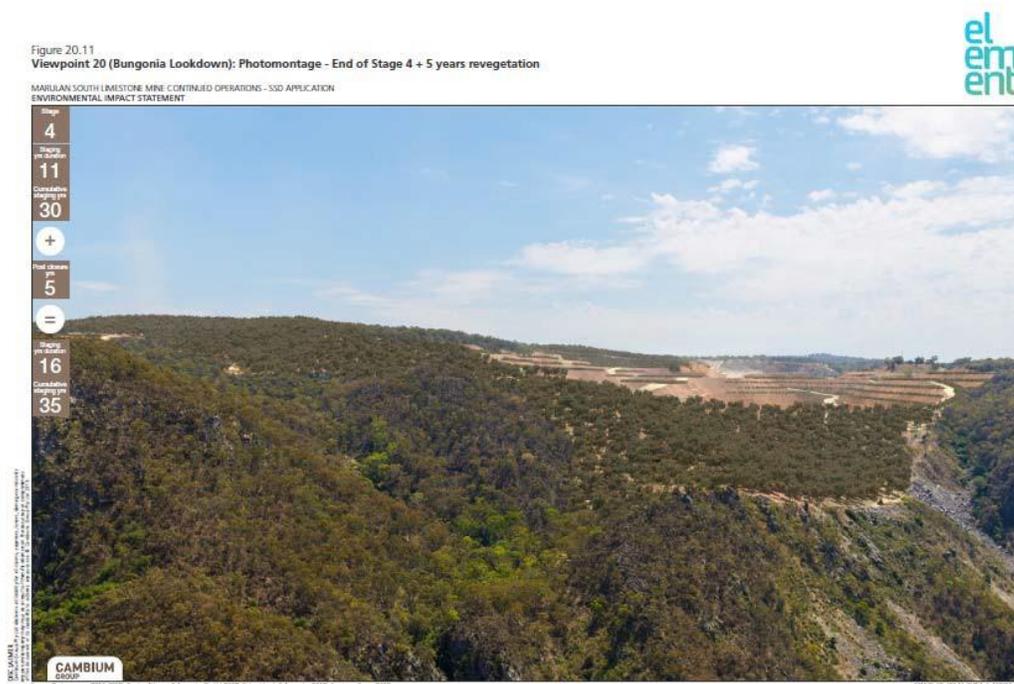
Figure 3 Conceptual 30-year Final Landform Design with Rehabilitation after 5 years

Figure 3 as viewed from the Bungonia Lookdown.

- improved visual amenity in particular from the Bungonia Lookdown as visualised in Figure 3. Backfilling of the southern end of the south pit, landform rehabilitation and revegetation with native woodland is a significant component of this RS.

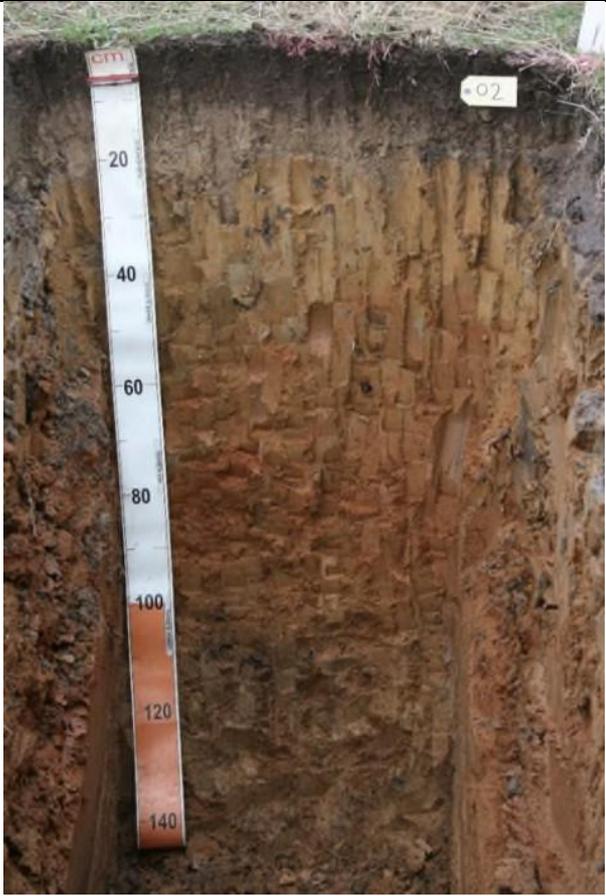
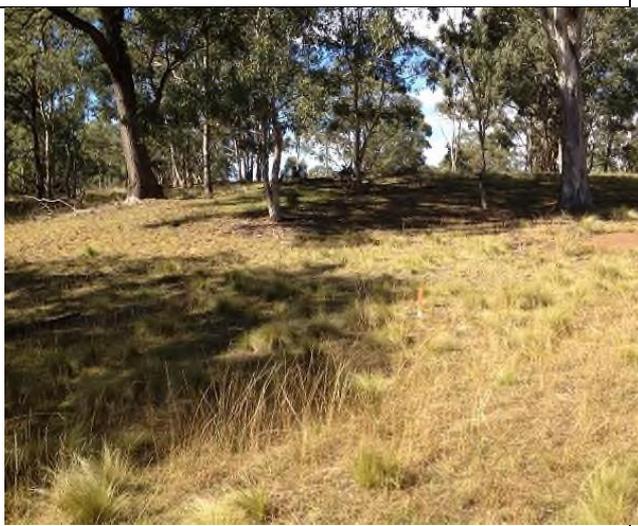
Soil Unit: Sodosol, Red/ Brown		
Representative Dominant Sites:	1 & 7 (Red) 2, 4, 8 and 12 (Brown)

Minor Sites	9 & 11 (Brown Chromosol)	
Typical Soil Profile	A1: 0-11 – Very dark grey loam, very weak angular-blocky, rough-faced, peds 30-40mm, moist, nil gravel	
	A2: 11-21 – Yellowish brown, sandy loam, weak polyhedral, rough faced peds, 20-40mm, moist, nil gravel	
	B2: 21-95 – Light olive brown heavy clay, apedal massive, moist, increasing weathered bedrock fragments	
	B/C: 95- >140 – weathered bedrock	Soil Profile Site: 2 (Brown Sodosol)
Roots:	Fine, few to 44cm

Landscape Association:	Mid to upper slopes	
Landuse:	Low density sheep grazing	
BSAL Status and limiting factors: Not BSAL. Fertility <i>Moderately Low</i> at all sites except 9 and 11. Indicators of poor drainage (such as distinct mottling) at all sites except Sites 1 and 2. Site 4 has pH (CaCl ₂) of 4.4 at < 600mm depth which also represents a chemical barrier at <750 mm depth. Site 9 has pH of 4.3 at <600mm depth and Ca:Mg ratio < 0.1 at < 750mm depth.

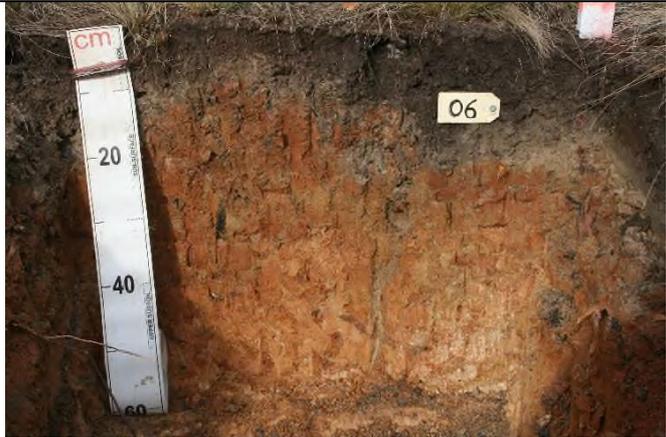
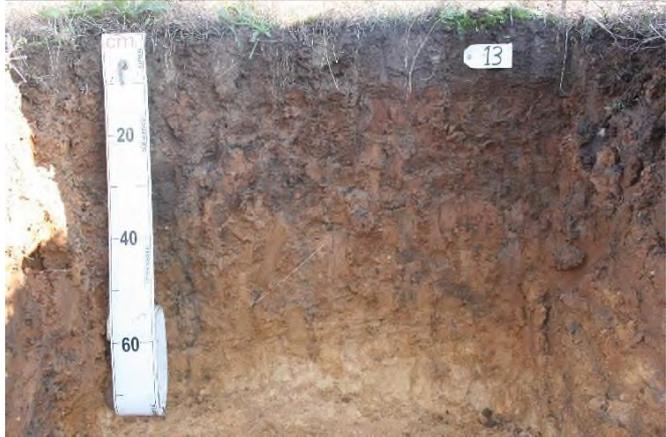
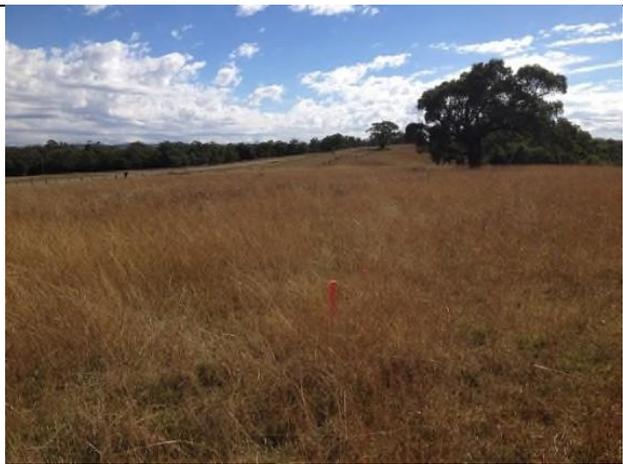
Soil Unit: Tenosol, Bleached-Orthic / Brown-Orthic		
Representative Dominant Sites:	3 & 6 (Bleached-Orthic)

Co-dominant Sites:	5 & 13 (Brown-Orthic)	
Typical Soil Profile	A1: 0-11 – Dark brown sandy loam, weak angular-blocky, rough-faced, peds 10-30mm, moist, 0-10% gravel

B2: 11-60 – Yellowish brown heavy clay, apedal massive	
	B/C: 60- >95 – weathered bedrock	Soil Profile Sites: 6 & 13
Roots:	Fine, few to 58cm

Landscape Association:	Crests and steep slopes	
Landuse:	Mine buffer land	
BSAL status and limiting factors: Not BSAL. Fertility <i>Moderately Low</i> at all sites. Physical barrier (typically high proportion of weathered bedrock fragments) at <750 mm depth at all sites; Site 3 has pH (CaCl ₂) of 4.3 at < 600mm depth, which also represents a chemical barrier at <750 mm depth. Indicators of poor drainage at Sites 3 and 6.

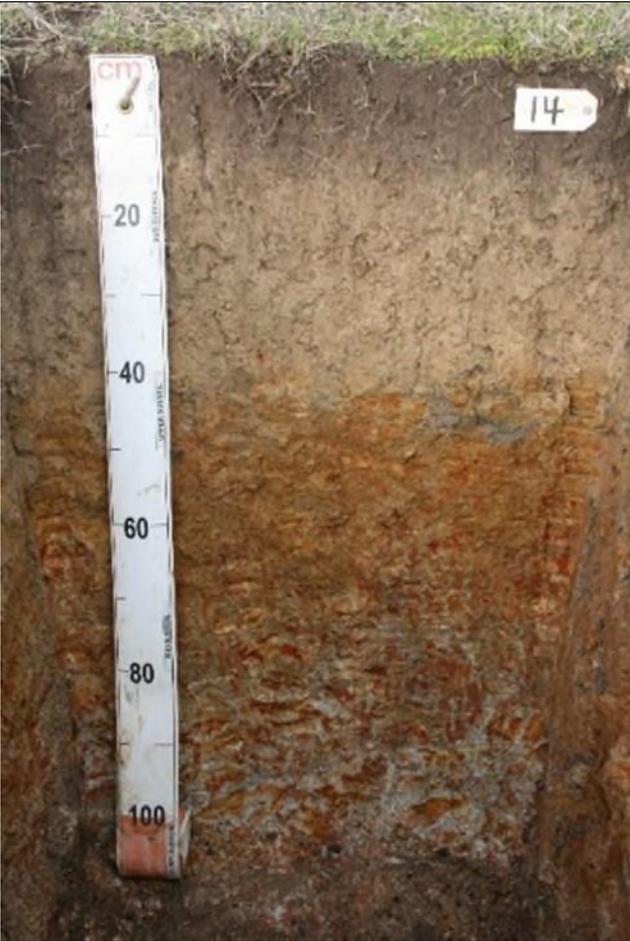
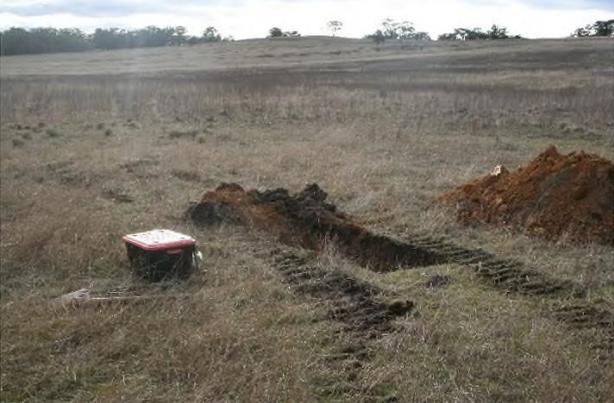
Soil Unit: Kurosol, Brown		
Representative Sites:	14

Typical Soil Profile	A1: 0-12 – Dark greyish brown sandy loam, weak polyhedral, rough-faced, peds 10-20mm, moist, nil gravel	
	A2: 12-44 – Light yellowish brown, sandy clay loam, weak polyhedral, rough faced peds, 20-30mm, moist, 20% ironstone nodules	
	B2: 44-65 – Yellowish brown medium clay, weak polyhedral to platy peds, 5-10mm, moist, 5% weathered bedrock fragments	
	B/C: 65- >110 – weathered bedrock	
Roots:	Fine, few to 57cm	
Landscape Association:	Flats and drainage depressions

Landuse:	Low density sheep grazing	
BSAL status and limiting factors: Not BSAL. Fertility ranking <i>Moderate</i> . Site 14 has pH (CaCl ₂) of 4.4 at < 600 mm depth, which also represents a chemical barrier at <750 mm depth. Indicators of poor drainage (bleached A2 horizon) at Site 14.

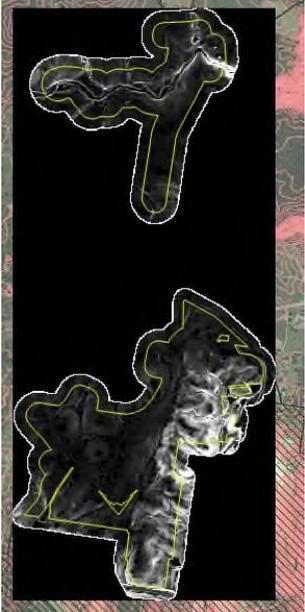
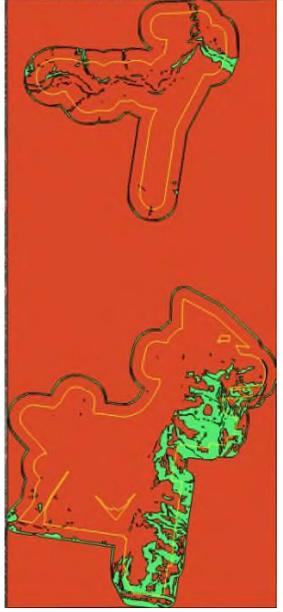
Step 1	Step 2	Step 3	Step 4	Step 5

An analysis of terrain within the BSAL assessment areas was undertaken to identify slope gradient greater than ten percent (10%), and exclude those areas from further assessment. LIDAR imagery of the assessment areas was collected in November 2014, and processed using QGIS as described below.

<p>LIDAR imagery of Project area displayed as raster layer in QGIS, with vector polygons of BSAL assessment areas shown in yellow.</p>	<p>LIDAR image clipped to 100m buffer around BSAL assessment areas and analysed for slope using QGIS <i>Terrain Analysis</i>, giving a range of 0-25% slope within the area.</p>	<p>QGIS <i>Raster Calculator</i> used to identify areas of slope greater than 10% (white areas).</p>	<p>Raster image converted to vector polygons, with brown areas representing slope less than 10%, and green showing areas greater than 10% slope.</p>	<p>Polygons clipped to BSAL assessment areas, with purple polygons representing those areas with slope greater than 10%.</p>
