# Dunmore Hard Rock Quarry Annual Review

## 1 July 2021 – 30 June 2022

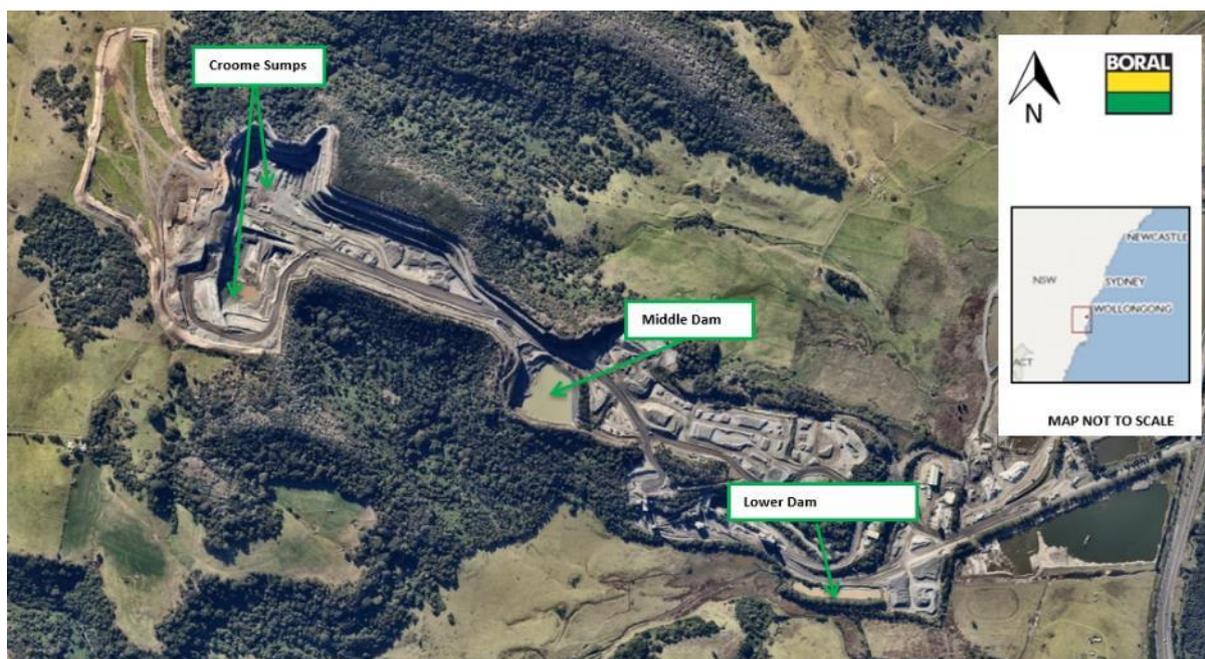
Figure 25 Water Storage Locations

Following periods of high rainfall, excess water is pumped to Middle Dam which overflows into the Lower Dam. Process water can be pumped from either the Middle Dam or the Lower Dam into storage tanks located adjacent to the processing plant area. This water is then used in the processing plant as well as filling the water cart for haul road dust suppression.

The location of water storage infrastructure is shown below in Figure 25 while a generalised schematic is provided in Figure 26.

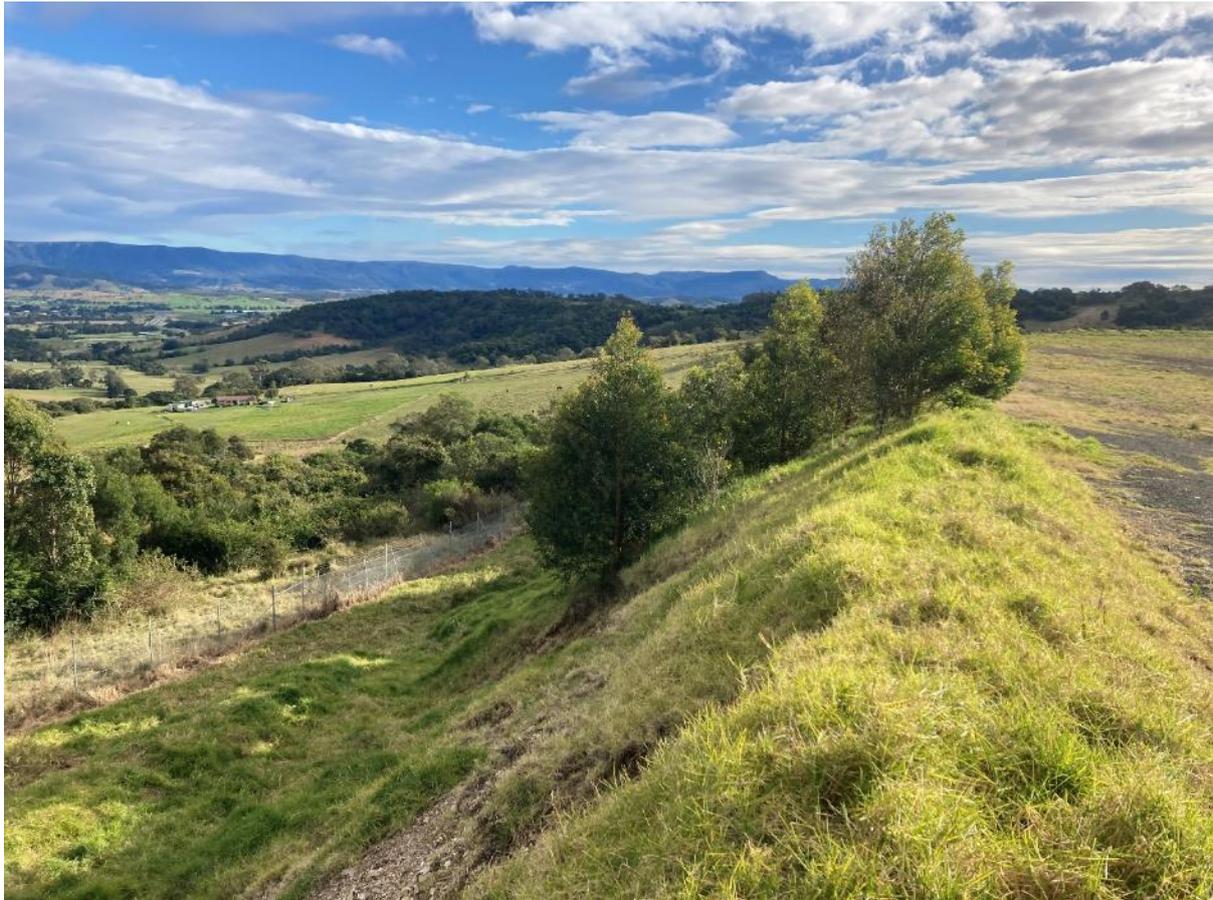
*Figure 28 Hydroseeding cover and trees over Croome West Bund*

Most areas of the site are currently operational and as such rehabilitation is not able to commence on the majority of areas within the quarry until the completion of extraction activities. When practical, progressive rehabilitation of the site will be undertaken in conjunction with on-going quarrying works. Hydroseeding of the Croome West Bund is now well established with trees as shown below in Figure 28.

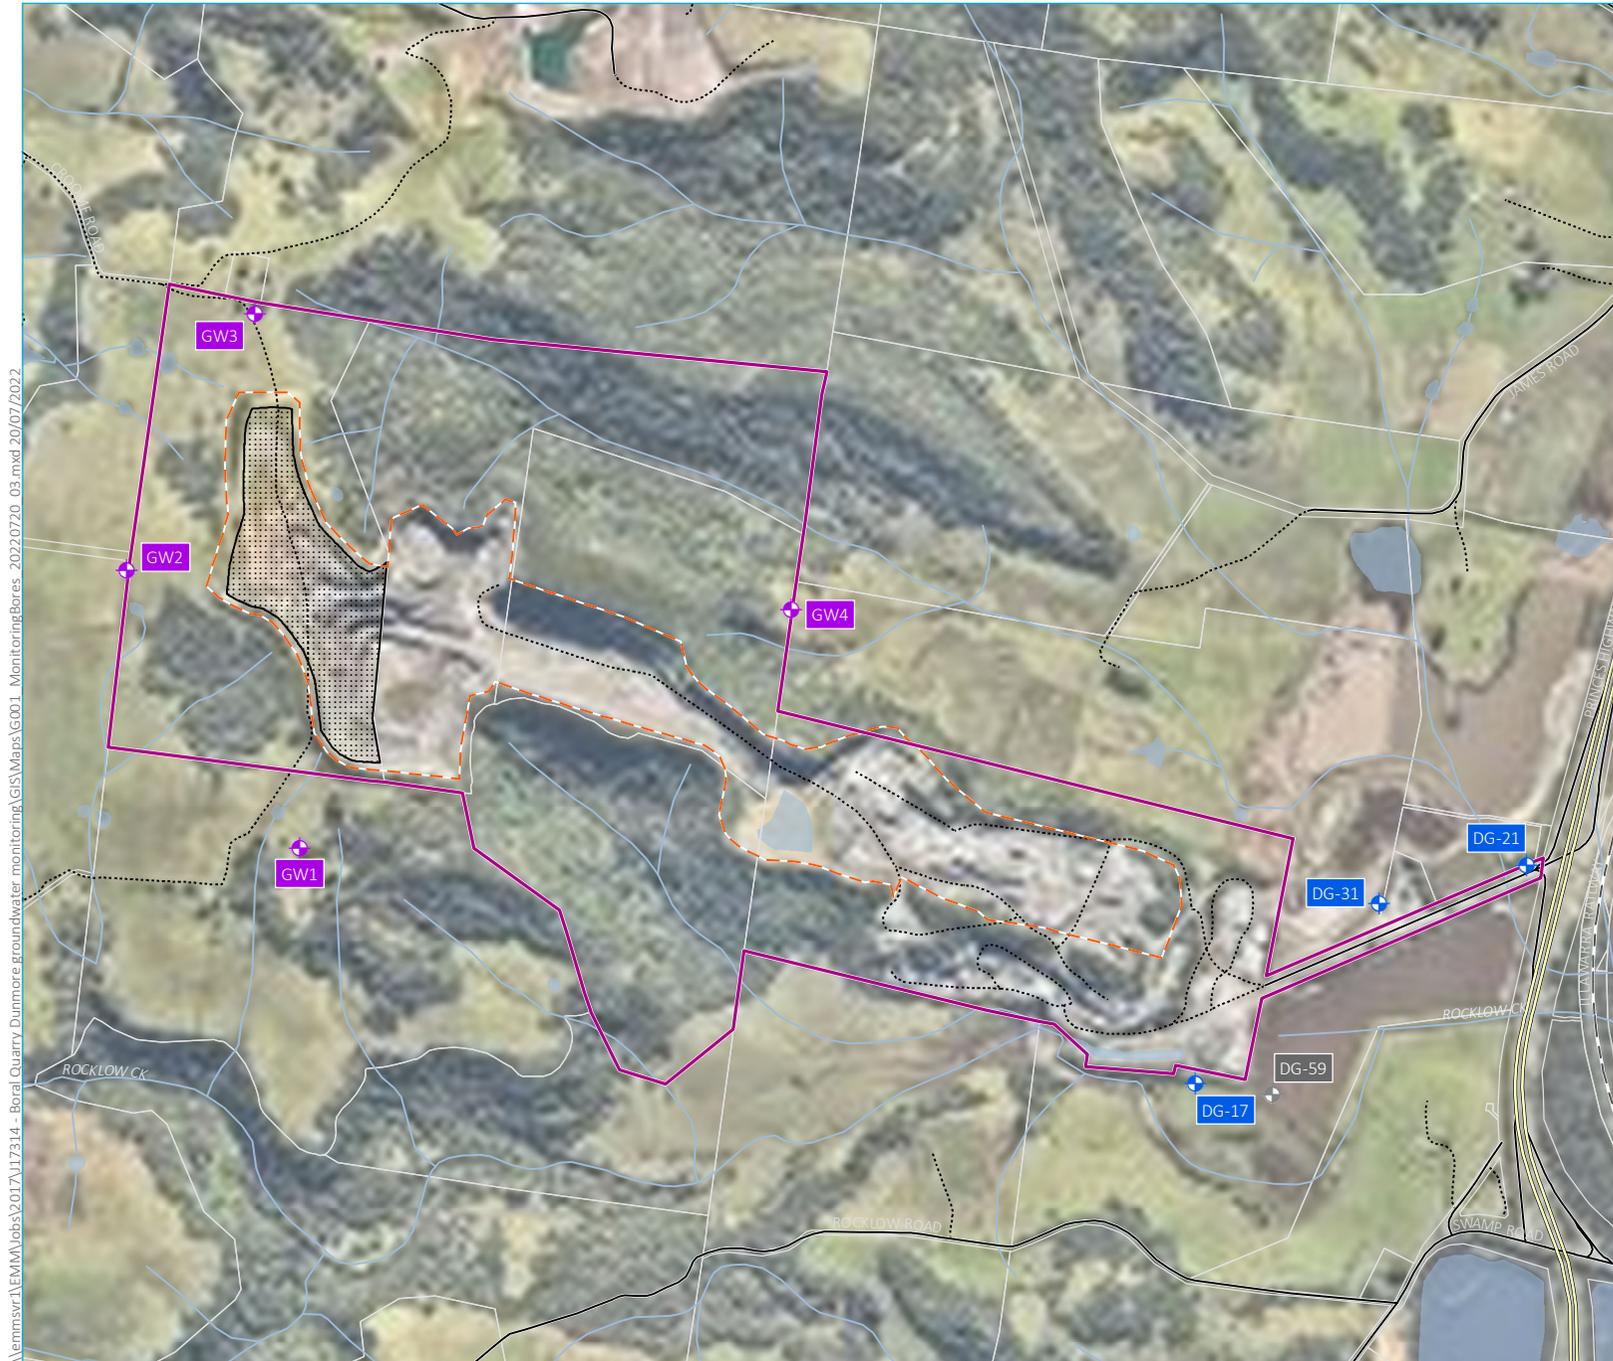
Boral Dunmore Quarry  
Annual groundwater monitoring report  
Figure 1.1

- KEY**
- Dunmore Quarry site boundary
  - Approved extraction area
  - Croome West pit extension
  - Rail line
  - Main road
  - Local road
  - Vehicular track
  - Watercourse/drainage line
  - Waterbody
  - Cadastral boundary
  - ◆ Croome West monitoring bore
  - ◆ Dunmore Sand and Soil monitoring bores
  - + Active
  - + Decommissioned

Site location and monitoring bores

Hard rock extraction from the Bumbo Latite of the Shoalhaven Group commenced at the quarry in the early 20<sup>th</sup> century. The quarry comprises one elongated open cut pit with an approved disturbance area of approximately 100 hectares (ha) (Figure 1.1). Site infrastructure includes a crushing and screening plant, product stockpiles, workshop and site offices located to the east of the pit.

Boral received approval for a pit modification to extend the quarry to the west (refer consent DA 470-11-2003) to enable the continued delivery of aggregate until approximately 2034, with the modified expansion area referred to as the Croome West pit (Figure 1.1). Staged extraction began in the 2017-2018 monitoring year with the construction of acoustic and visual bunding. During the 2018-2019 and 2019-2020 monitoring years, extraction continued in the Croome West pit moving slowly north, with overburden placement in the northern section of the formerly mined Croome pit. Throughout the 2020-2021 extraction has continued in the Croome West pit towards the west. The final pit will be extended both laterally and vertically with a maximum proposed pit depth of 60 metres Australian Height Datum (mAHD) in the Croome West pit. The recent Modification 13 proposes to extend the quarry north into the (formerly) Sydney Trains land with a pit depth of 43 mAHD.

- conduct groundwater monitoring which includes a six-monthly groundwater sampling event at the Bumbo Latite monitoring bores located up hydraulic gradient from the quarry (Figure 1.1);
- analyse and interpret water level and water quality data obtained from the Bumbo Latite monitoring bores with reference to the conceptual model where relevant; and
- analyse and interpret water level and water quality data obtained from the Dunmore Sand & Soil (DSS) quarry monitoring bores located in the alluvium down hydraulic gradient from the quarry (Figure 1.1), relying on data collected and processed by International Environmental Consultants (IEC).

The monitoring network, designed in accordance with the GMP, consists of seven groundwater monitoring bores (refer Figure 1.1 and Table 3.1). In summary:
